THE DESIGN, CONSTRUCTION, AND MAINTENANCE OF A GRAVITY-FED
WATER SYSTEM IN THE DOMINICAN REPUBLIC

A REPORT

MASTERS OF SCIENCE IN CIVIL ENGINEERING

MICHIGAN TECHNOLOGICAL UNIVERSITY

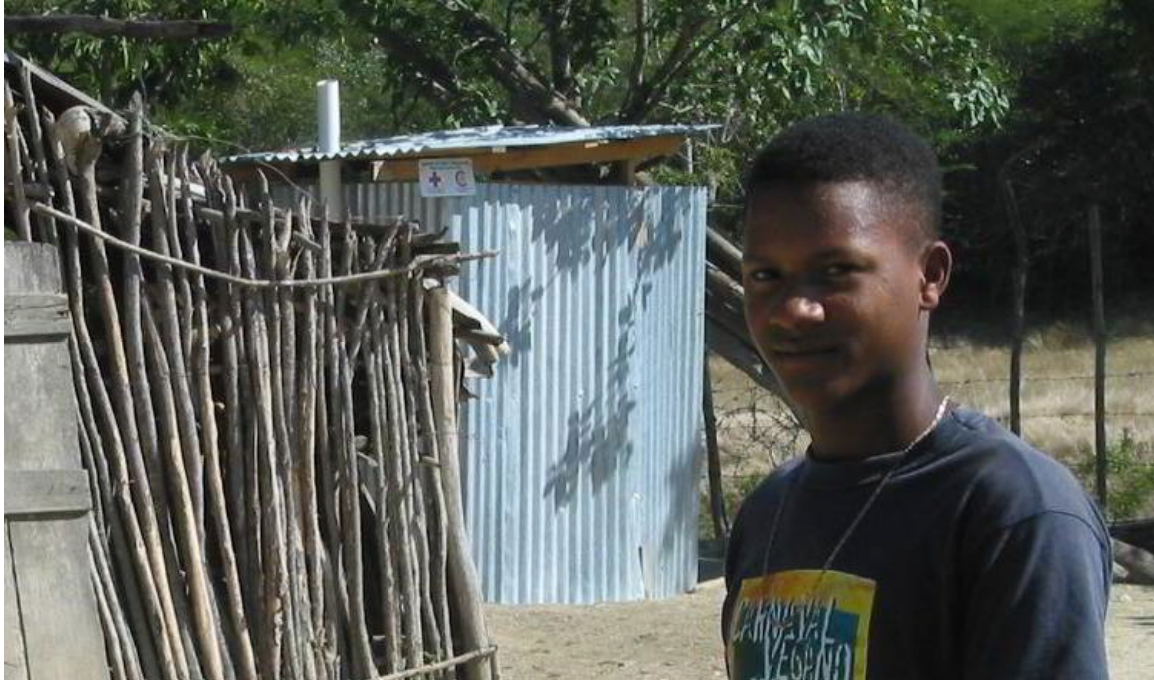
Figure 3.2 Typical latrine seen in the Southwest region of the Dominican Republic

Typical living conditions consist of a two or three-room house made with palm board siding. All homes are painted a variety of bright colors. About ten percent of the community has concrete floors, while the remaining houses have earthen floors which over the years have been packed down sometimes seemingly as strong as concrete. Almost all houses have roofs made of four-foot pieces of galvanized corrugated sheet metal constructed in an overlapping manner. The poorer families overlap dried banana leaves which render the home almost rain-free. All homes use separate buildings as their kitchens. These small buildings are not given as much importance as the main home and consist of old unpainted palm board and banana leaf roofs. Three of the five communities have latrines that have been built by development organizations in the past. (see Figure 3.2)

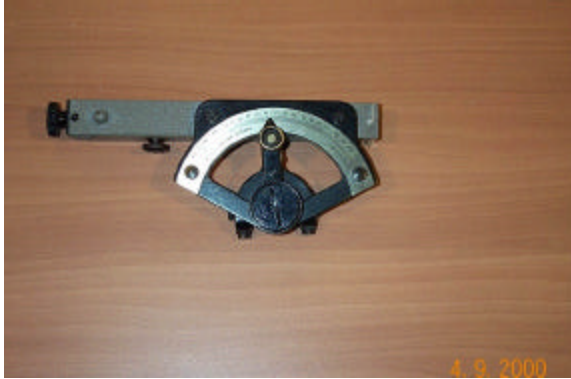
Figure 4.3 Typical Abney Level

The equipment used for the land survey consisted of an Abney Hand Level, since transits or Total Stations were not available. The Peace Corps had Abney Hand Levels available for our use. Abney Hand Levels typically consist of a tube (dimensions of about 16 x 1.5 x 1.5 cm) with an eyepiece at the observer's end and horizontal cross-hair at the objective end (see Figure 4.3).

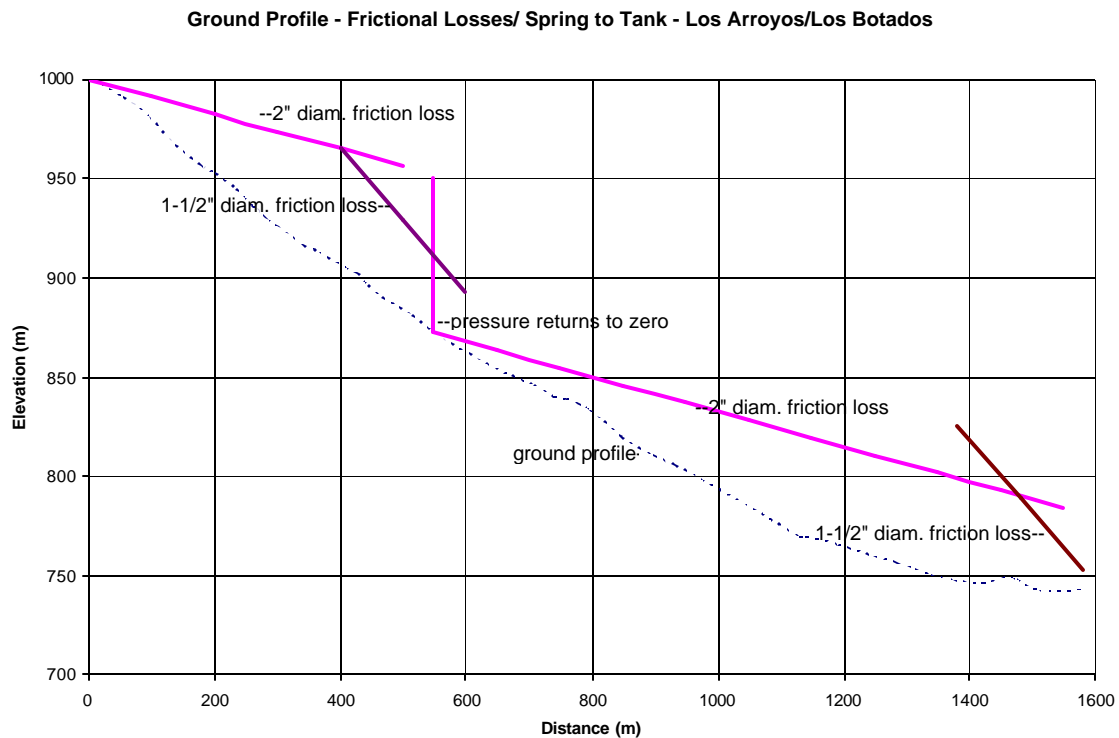
Figure 4.9 Representative Hydraulic Grade Line plotted against Ground Profile.

diameter increases, the friction losses decrease. Trials are performed by hand, plotting out each headloss factor in m/100m of each proposed pipe diameter on the previously plotted ground profile. These plotted lines are referred to as the Hydraulic Grade Line (HGL). This is illustrated in Figure 4.9.

between the original spring elevation and ground profile elevation at any chosen point. A general rule of thumb is that static head at any given point with a good factor of safety should not exceed 100 meters (328 ft) of head (Peace Corps Personal Training Notes, 2001). The difference in head from the spring to tank is 260 m (853 ft), therefore one or two break-pressure tanks are needed. The function of a break-pressure tank is to allow the flow to discharge into the atmosphere, thereby reducing its hydrostatic pressure to zero, and establishing a new static level (Jordan 1982). I decided that one break-pressure tank would be installed at the midpoint of the elevation change due to land issues and to save money on the project. The static head at that point is 130 m (426.5 ft). This was above the recommended allowable static head, however, the actual maximum allowable head pressure for a Schedule 40 PVC pipe is 183.4 meters (400 psi).

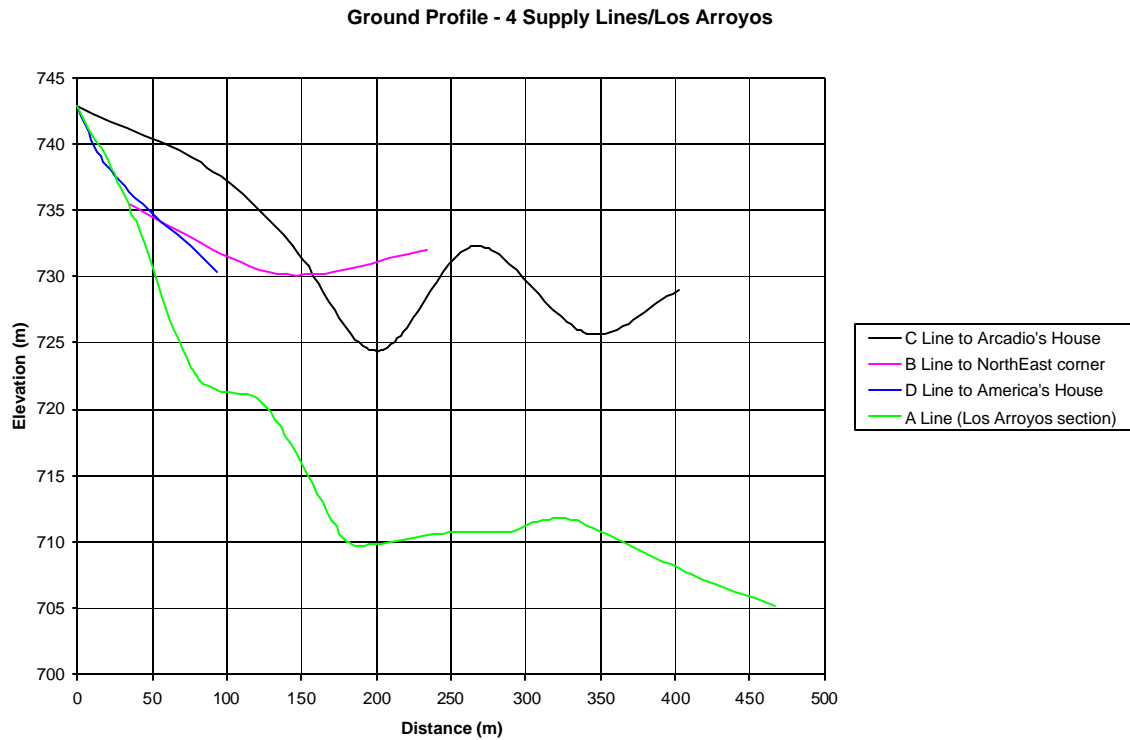
Figure 4.10 Ground Profile of Four Branch Lines

Figure 4.10 shows the ground profile of the three branch lines that leave the tank. Two of the lines are supplying the community right at the tank.

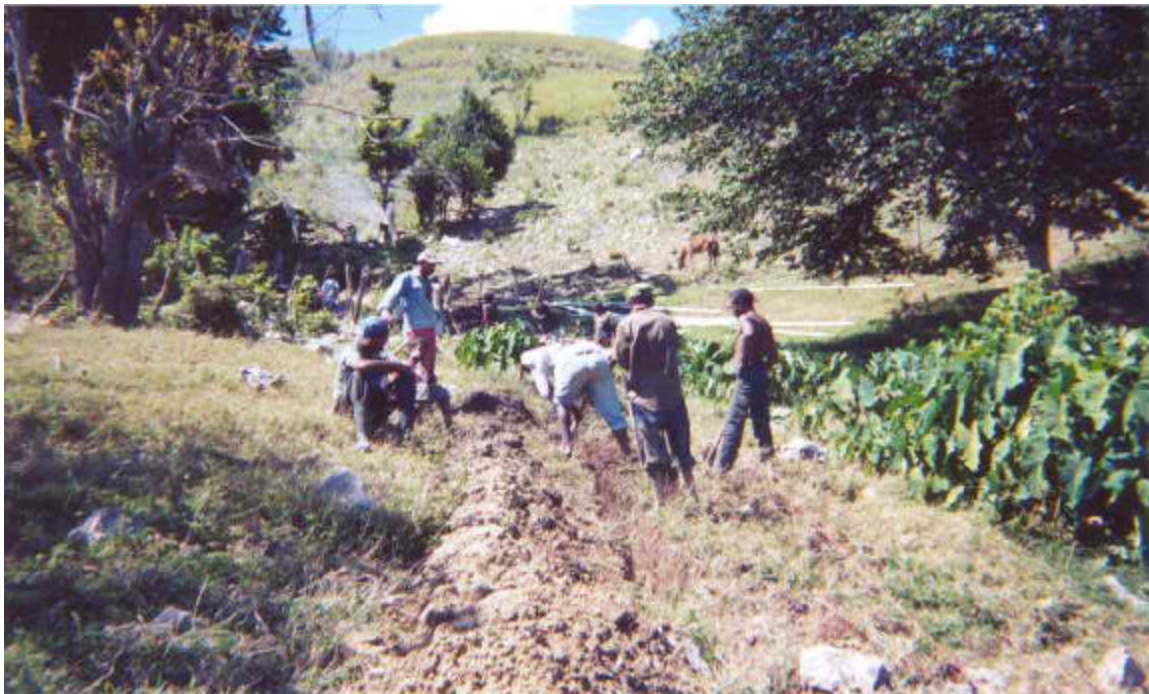
Figure 4.16 Work brigade digging pipeline trench

The constant problem involved in this phase of the project was making sure the trenches were dug deep enough. From day one, it was explained that the ideal depth to put the

tubes was one-meter deep. This measurement was recommended in Peace Corps training for maximum protection of pipeline. After a few hours of digging, it was evident that because of the rocky soil, two feet would have to be sufficient. Still, the men would ask if their area was deep enough, after digging less than a foot deep. The knee was used as a reference point. However, even though each man understood this, they still wanted approval for their work. This was never resolved; I was constantly instructing the brigades if their trench was deep enough. During the first month, I worked with the brigades on every work day. During the following months, I would work one of the two days, leaving one of the brigade leaders with instructions. Figure 4.16 shows a brigade admiring the trench they dug through one of the many fields that were crossed.

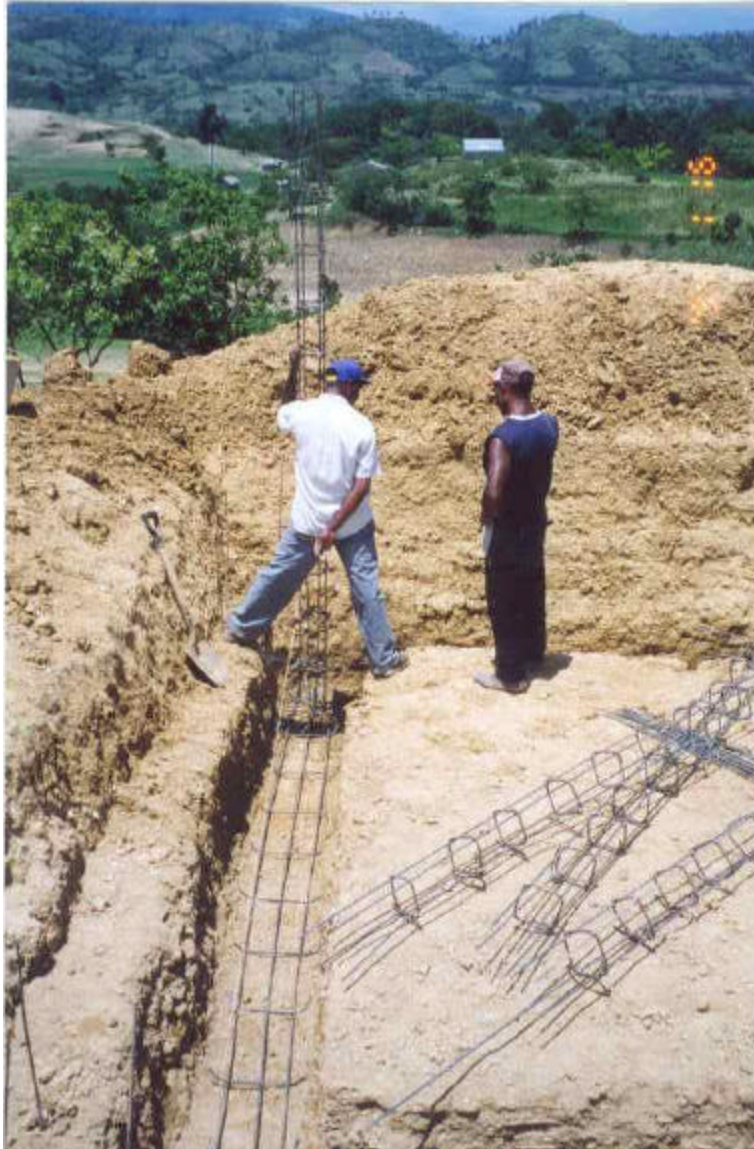
Figure 4.17 Footing trench

The footings were measured and squared off by the two masons who were hired labor from a neighboring community, who had some similar experience. With the foundation dimensions, another brigade had to dig another half-meter deep to prepare for the concrete footings. Figure 4.17 shows the completed footing trenches, and the masons preparing the rebar for the footing and corner columns.

Figure 4.17 also shows the prepared rebar for the columns. The columns were designed for the corners of the tank. They were constructed of 4-3/8-inch (no. 3 bar) rebar tied together with rebar “hooks” located every 12-inches. These rebar columns were tied into the foundation rebar with tie wire.

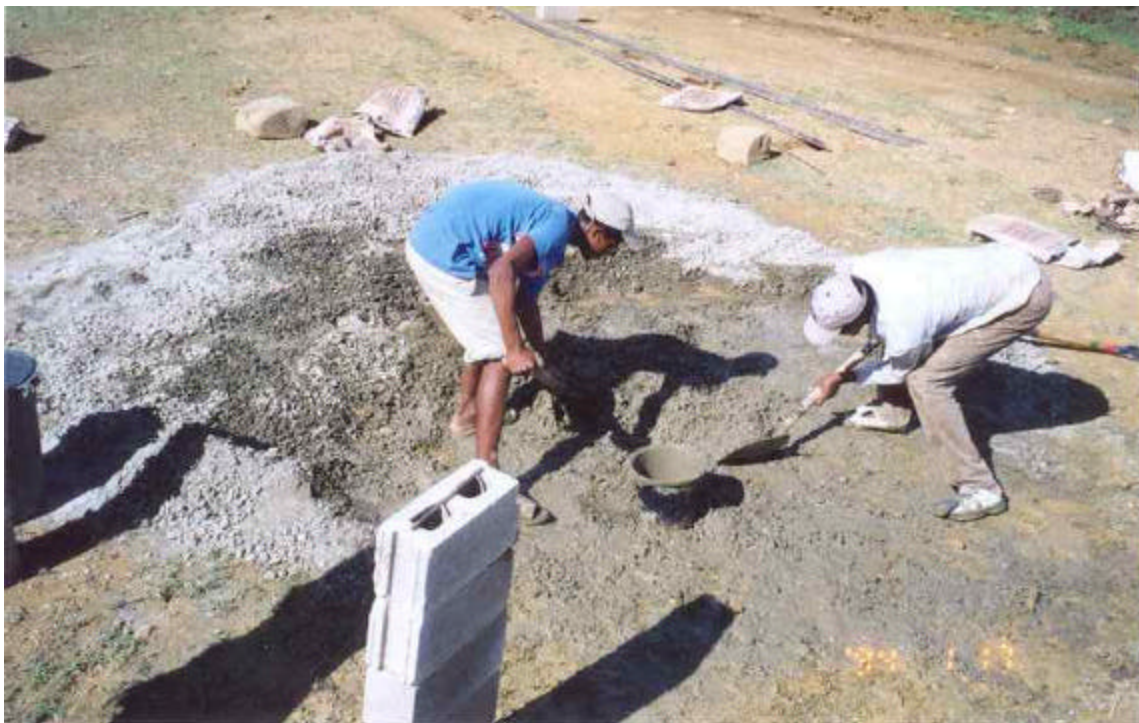
Figure 4.18 Mixing concrete

what part of the tank is being worked on. A thicker mix is desired for the foundation and thinner mixes for the columns and bond beams for ease of filling in around all rebar. The desired foundation mix was one part cement to two parts sand, and two parts gravel. Typical mortar mixes for placing block are negligible, as long as the mix is thick enough to adhere to each block. Figure 4.18 shows a prepared dry mix, as workers prepare one side with water. Unfortunately no one bucket of concrete had the same ratio of cement to sand, water or gravel. It was not uncommon to find small amounts of dirt, or small clumps of dried concrete or sand that never got mixed thoroughly. Since the concrete consistency could not be controlled, additional rebar was used throughout each tank.

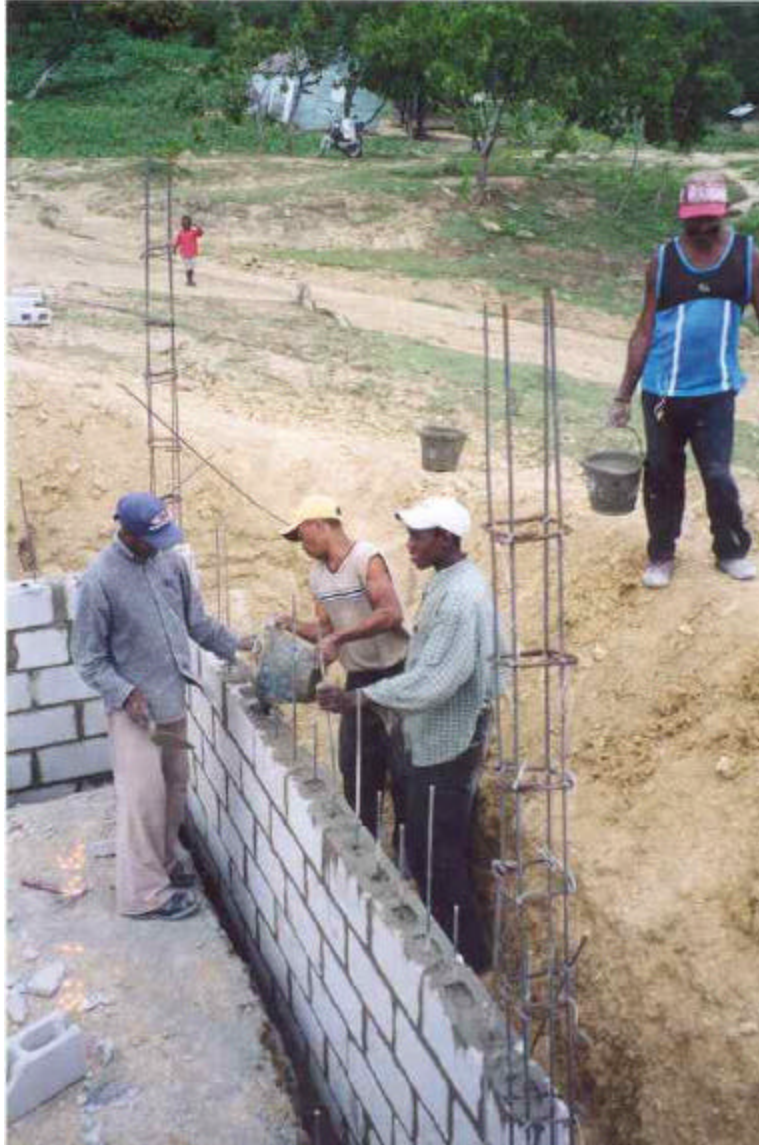
Figure 4.19 Filling in Block Cavities.

Once the foundation was cured for 24 hours, six lines of block were laid. Existing rebar which had been tied into the foundation rebar, were extended up through each block cavity. Every cavity had a piece of rebar and was filled with an even concrete mixture of sand and gravel, and half cement. Water was added until it was a soupy mixture. Figure 4.19 shows the masons and community members filling in blocks.

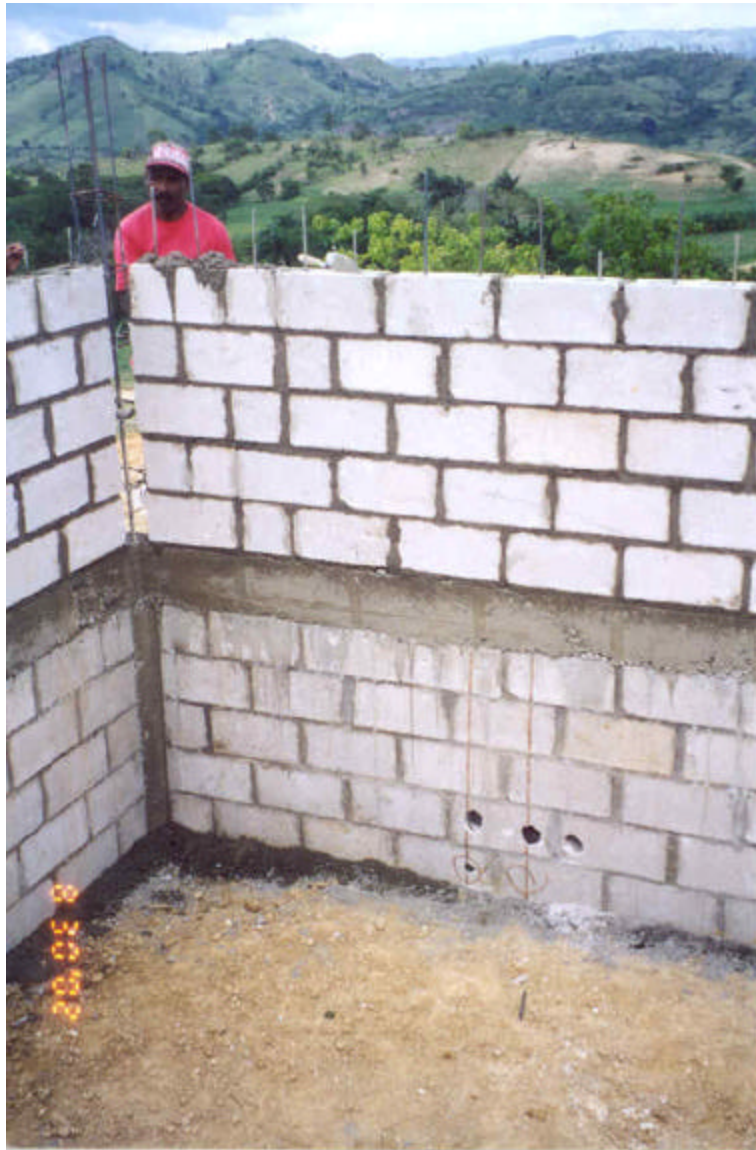
Figure 4.20 Rough interior walls

first six lines of block. Rebar was extended, and all cavities were filled in with a soupy concrete mix and the walls were left to cure for 24 hours. Figure 4.20 shows the interior of the completed rough wall. The mason is standing on level ground by the outside of the tank. The comparison of the depth of tank to ground level is shown.

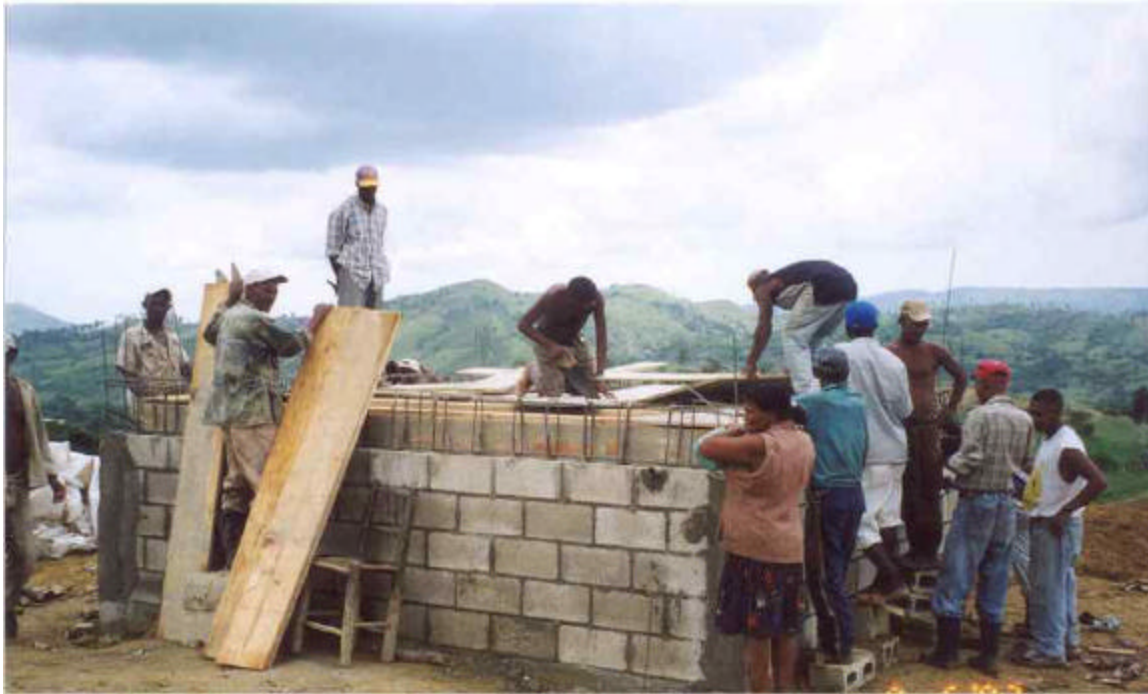
Figure 4.21 Bond beam and false floor construction

in both directions. The final step was to cut 2-foot strips of plywood and nail them down. The plywood had to be cut in 2-foot strips because the access door we were installing on the top of the tank was 2-foot square, and all lumber had to be removed, through the access door, once the roof was allowed to cure for several days. Figure 4.21 shows the bond beam rebar and the crew preparing the false roof.

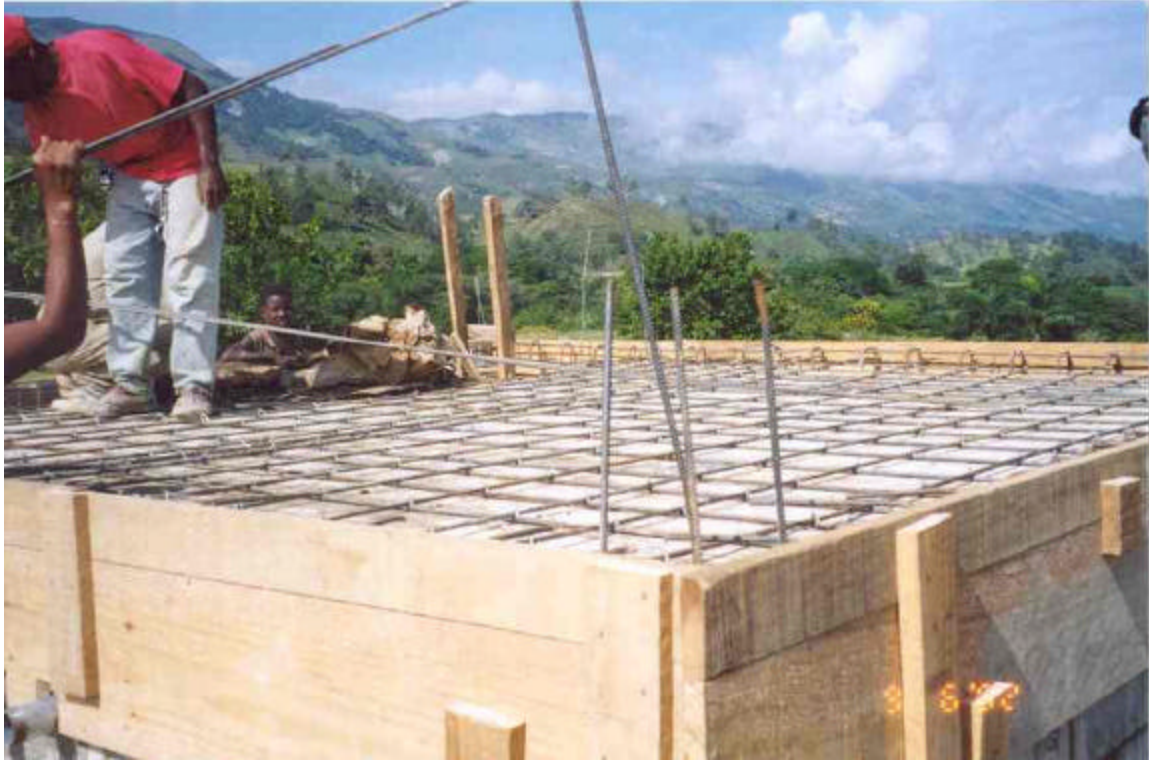
Figure 4.22 Roof rebar preparation

Once all forms were installed the final preparation before casting the bond beam and roof was to prepare the rebar and access door. 3/8-inch (No. 3 bar) rebar was used on 10-inch centers (Jordan 1980). For additional support, three 1/2-inch pieces of rebar were tied in the center running in each direction. The access door was tied into the rebar, positioned at the elevation of finished concrete. Figure 4.22 shows rebar in place and ready for concrete.

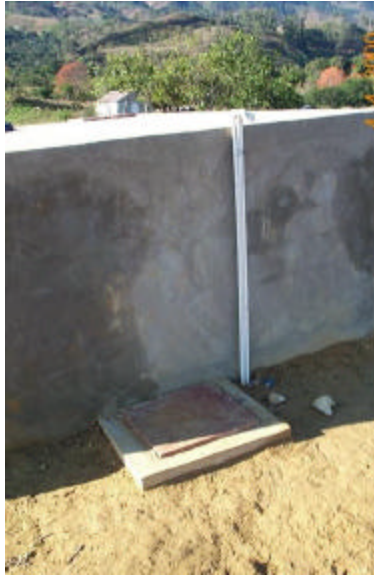
Figure 4.23 Security valve box/respiration tubes

anything they could get their hands on. Figure 4.23 shows the top of the security box with three respiration pipes originating from the box located on the right.

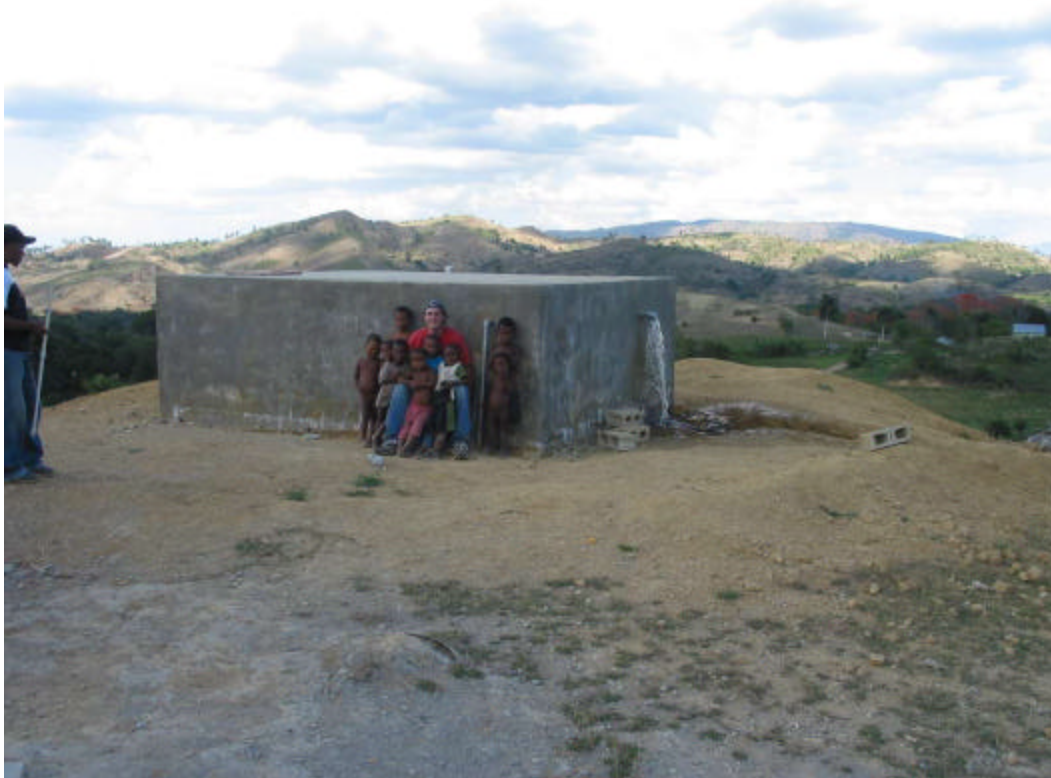
Figure 4.24 Water storage tank

The final step for the water storage tank was to connect the main transmission tube to the tank. Additionally, an HG pipe was installed for the cleanout with the opposite end exiting the side of the hill. HG elbows were installed on the two cleanout nipples. The final product can be seen in Figure 4.24, and a picture of the overflow tubes can be seen in Figure 4.25. When the system was finally put into service, it turned out that the supply was much greater than the demand, so the storage tank, constantly overflowed. This caused major panic within the community because the water eroded away a significant amount of earth. The community had to stack a large amount of rocks in the eroded area, as well as dried banana leaves in attempt to redirect the force of the overflowing water. (see figure 4.25) Additionally a small trench had to be dug to direct the overflowing water back to the local river. The community had no water, and now they had too much.

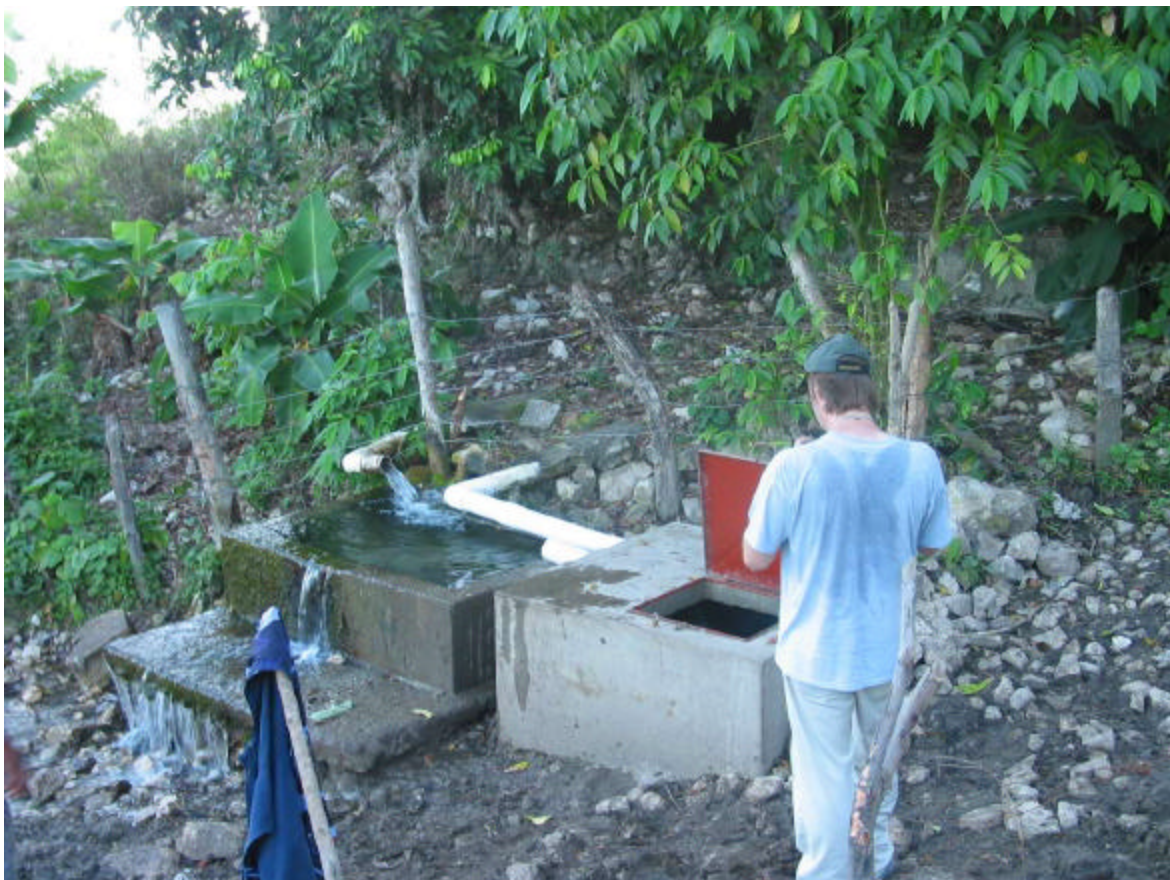
Figure 4.26 New and existing spring construction

As mentioned previously, the spring that was used as the source of my gravity fed water system was in-use by another community who had constructed their water system with a previous Peace Corps Volunteer. Our decision was to use one of the overflow tubes from the existing catchment. Since no catchment was needed, all we needed to build was a transmission tank. This tank would serve the exact same purpose as a break-pressure tank. The tank would receive water and exit into the main transmission line. Figure 4.26 shows existing water system on the left, with the newly built transmission box on the right.

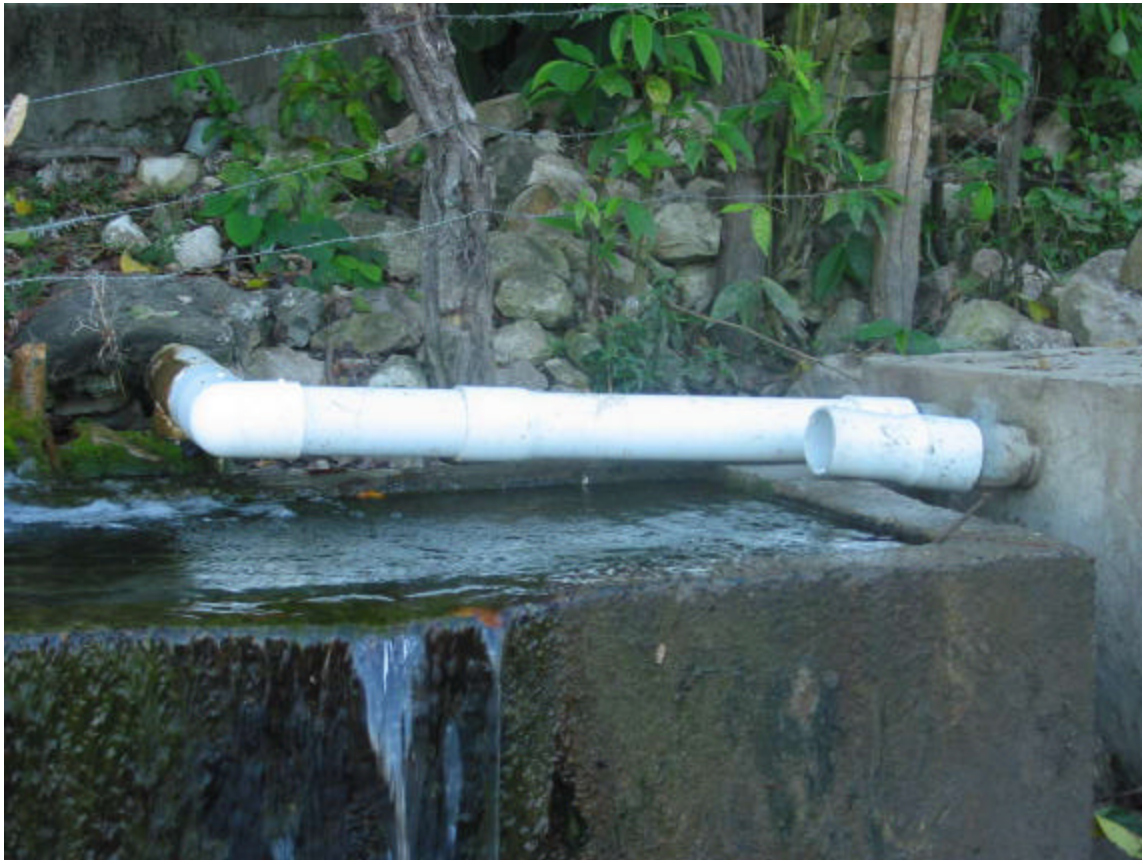
Figure 4.27 Connection to transmission tank

As shown in Figure 4.27, the overflowing trough provides water for animals. There are two 4-inch PVC pipes coming out of the ground that act as overflows. The closest to the new tank was used as the supply for the new water system. A 4-inch PVC elbow was connected. In addition, 4-inch PVC pipes were used to make the connection to the new tank.

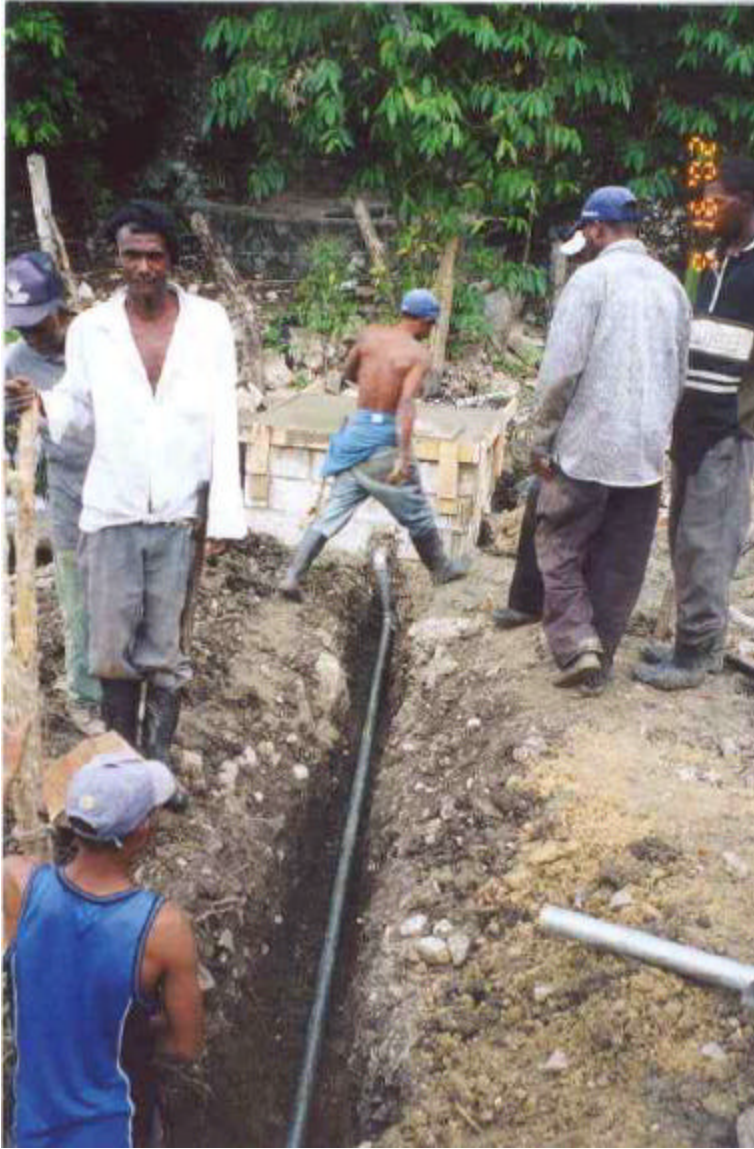
Figure 4.28 Transmission tank exit piping

The work site was located on one of the well-traveled paths in the area. Men brought their animals from great distances to drink water. To protect from the weight of the many animals, the exit pipes had to be galvanized pipe. The pipe exits and immediately is connected to a galvanized elbow. With another short galvanized nipple and galvanized elbow, the line proceeded to cross the path about two feet underground in 2-inch galvanized pipe. (See Figure 4.28)

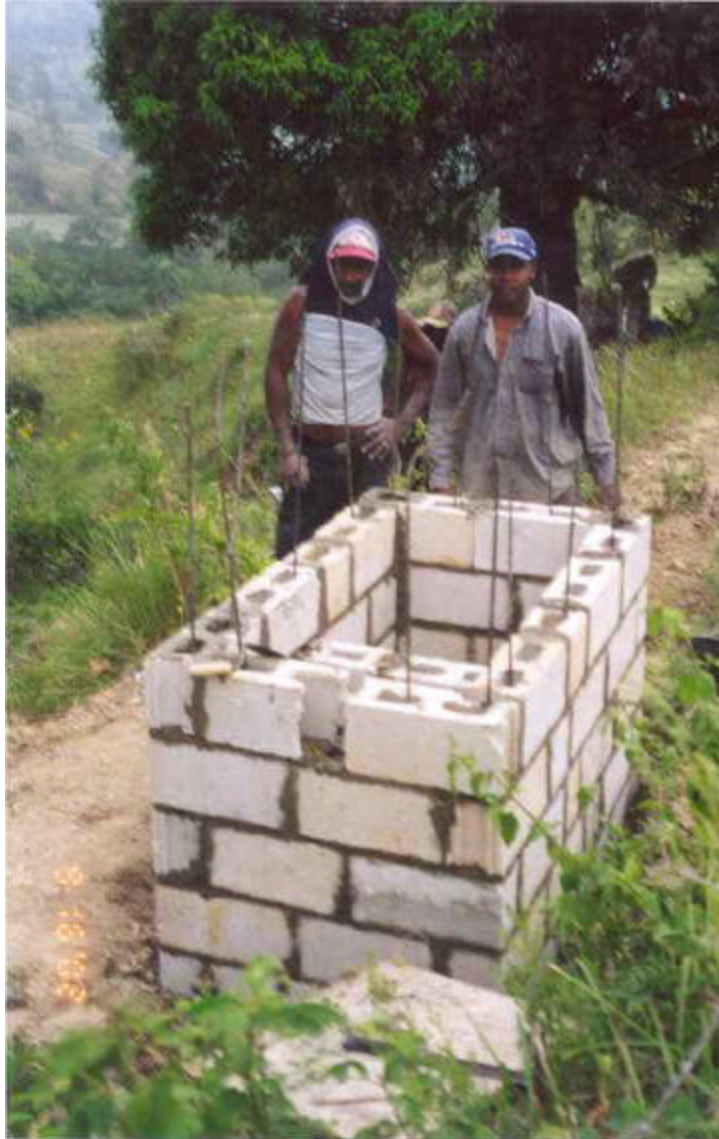
Figure 4.29 Break-Pressure Tank under Construction

The entrance and exit piping was changed to galvanized pipe as it came out of the ground and went back into the ground to protect the pipeline from animals or humans damaging it. An overflow pipe was also installed in case of any blockage in the pipes below the tank. A small ½-inch HG nipple was installed in the first compartment to be used as a public water spigot. Figure 4.29 shows the tank under construction and Figure 4.30 shows the finished tank.

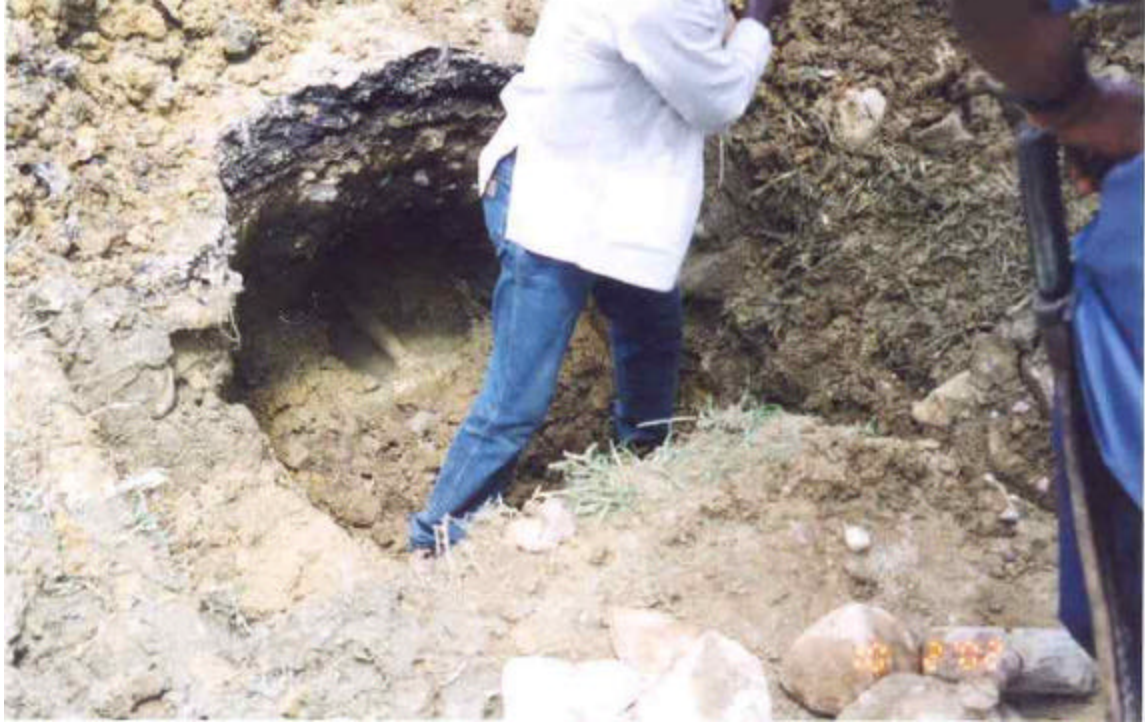
Figure 4.32 Searching for existing connections

The existing pipeline was cut and connected to the community's supply line shortly after permission was granted. During pipeline construction in the second community of Los Botados, many problems with the existing system became apparent. Among them, one woman thought that a twenty-foot stretch was all blocked up with debris. (This was later found to be untrue.) A large problem that was not voiced when the design was created was that there were several locations where a branch of the pipeline crossed the road, and the divisions were located below the asphalt. Since some of these connections were said to have leaked in the past, it was necessary to break up the road and drainage ditches to find the existing connections and repair them. Figure 4.32 is an example of breaking through the asphalt and locating an existing connection.

The majority of the work in Los Botados was to find the existing pipeline that branched off to each home, clean it up, and install new pipes to the location of the new tap stand. Additional work was required when the system was pressure tested. These problems were located and repaired as needed.

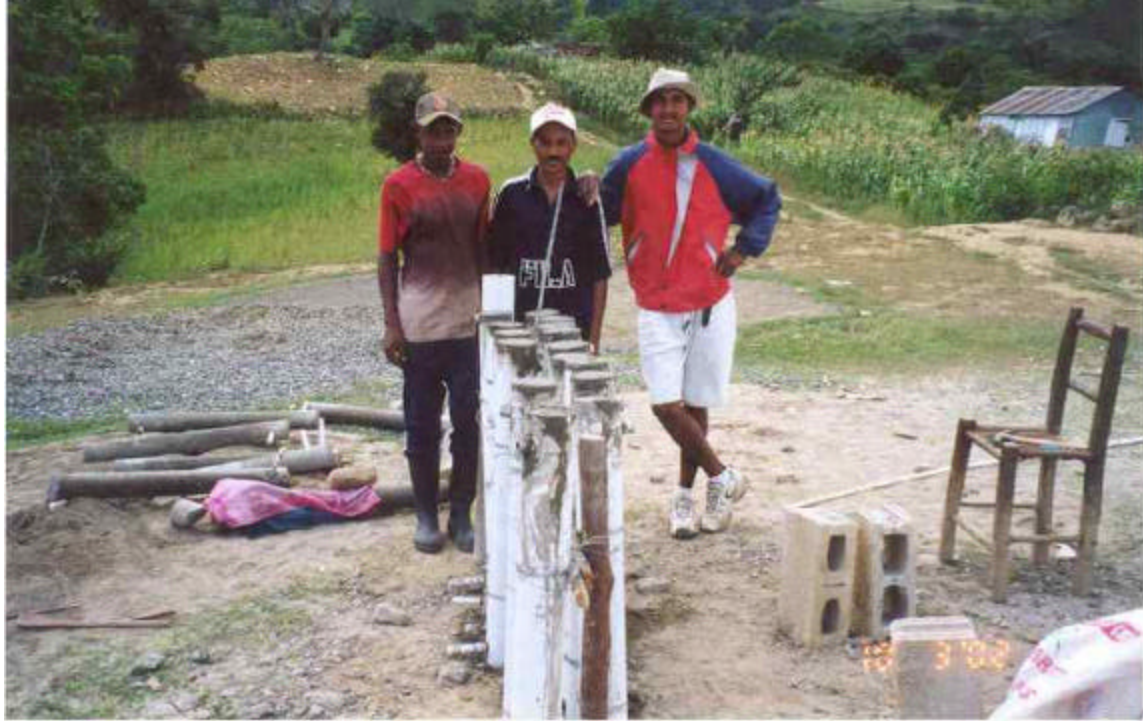
Figure 4.33 Tapstand construction

Using a one part gravel, two parts sand to one part cement mix, fifteen tapstands were built each day. After twenty-four hours in the mold, each tap stand was removed and submerged in water to cure for 7 days at 100% humidity. Seventy-five tap stands were constructed in five days. Figure 4.33 shows the method used to reproduce the tapstands.

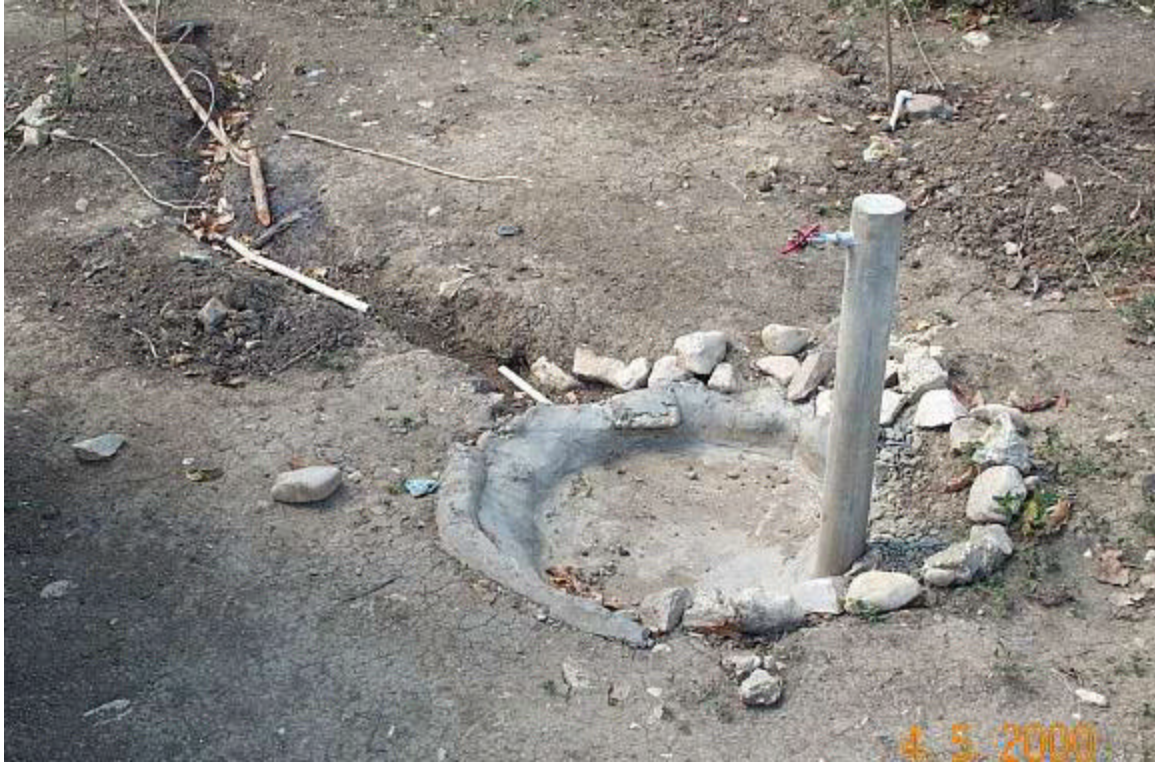
Figure 4.34 Installed tap stand

Each tapstand was connected to the supply line going to each house. Once the pipes were connected a small splash area was made. This splash area was constructed with a concrete mixture and small rocks found in the area to take up space. The purpose of the splash area was to keep the surrounding area free of mud, and to serve as structural support for the tapstand. A small piece of $\frac{1}{2}$ -inch pipe was installed for drainage. The final step was to install the water spigot. Figure 4.34 shows a picture of an installed tapstand.

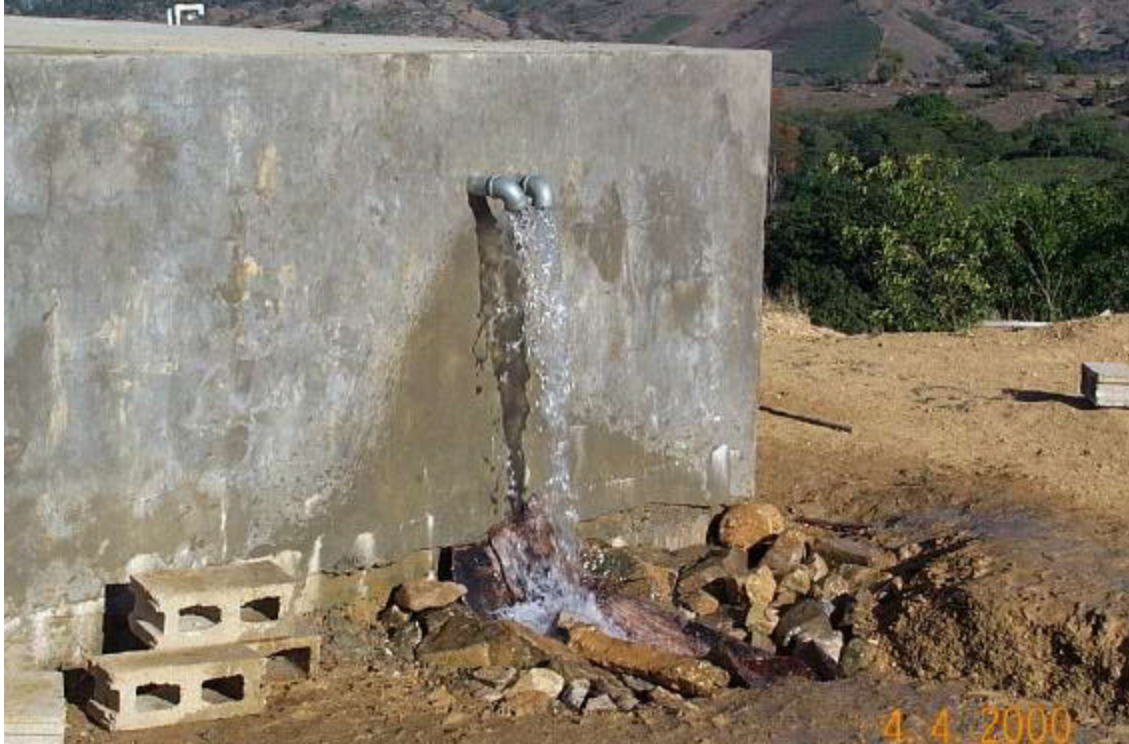
Figure 5.1 Water storage tank overflow – Unutilized volume above overflow.

While building the water storage tank, allowance for height of the upper bond beam and roof were not accounted for. Therefore, the overflow pipes were installed in the last level of block, before the bond beam was prepared. After the roof and bond beam were finished, it was obvious that we lost a good amount of volume of the tank above the overflow pipes, which were useless. Figure 5.1 shows overflow pipes and the space lost above them. Approximately 1,000 gallons were wasted. Since the supply already appeared to be much higher than the demand, nothing more was done to address this problem.
