Hydrology of Sand Storage Dams

A case study in the Kiindu catchment, Kitui District, Kenya

1 February 2006
Master thesis Hydrogeology
Code 450122
27 ECTS

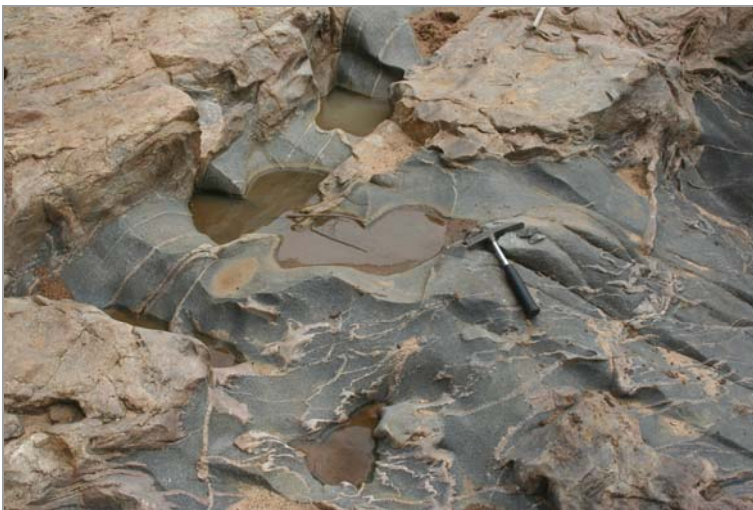
Figure 2.11 Granitoid gneiss (left) and biotite granitoid gneiss (right) with pegmatite veins

In the case study area in the Kiindu catchment rock types are found, mainly gneisses, such as granitoid gneiss (feldspar, quartz and muscovite), biotite gneiss (biotite, feldspar and quartz), intersected with pegmatite veins (Figure 2.11). The gneisses appear in bands differing in width from half a meter to tens of meters. Locally some quartzites appear between the gneisses. The structural trend of all rocks found in the research area are between 0° and 35°

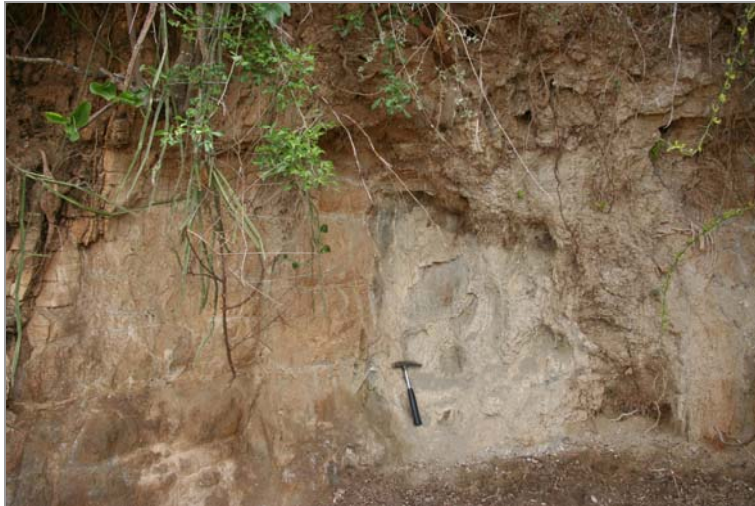
Figure 2.12 The white part is sodic feldspar and is about 1 meter wide

All of these rocks dissolve slowly in water, therefore the water chemistry doesn't change rapidly. At some locations however bands of saline rock were found (Figure 2.12), which tasted very saline, but only when it is weathered. Unfortunately this rock could not exactly be identified. This saline rock influences the water quality much more than the other rocks: the salinity of the water increases dramatically.

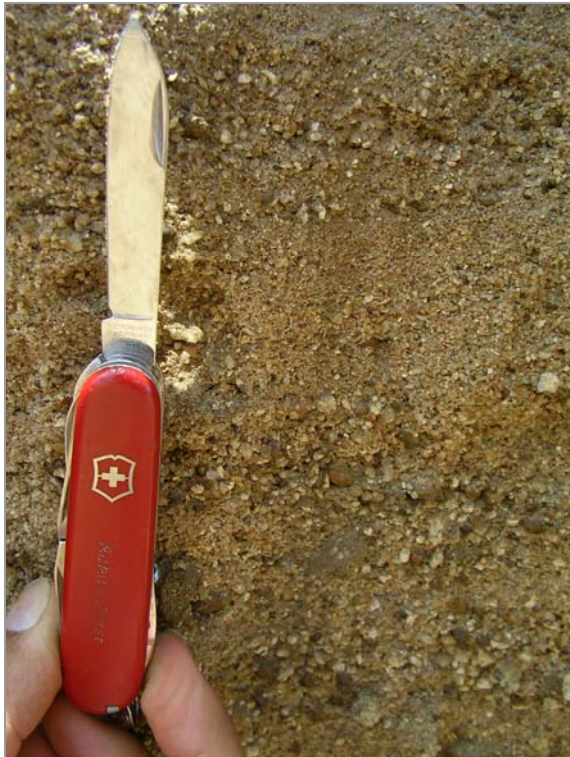
Figure 2.13 The riverbed is filled with coarse sand

The riverbed itself is filled with coarse sand (about 600 μm), which is an erosional product of the different local lithological units, mainly gneisses, (Figure 2.13) and forms a phreatic aquifer has a thickness varying from a few centimetres to more than 2 meters.

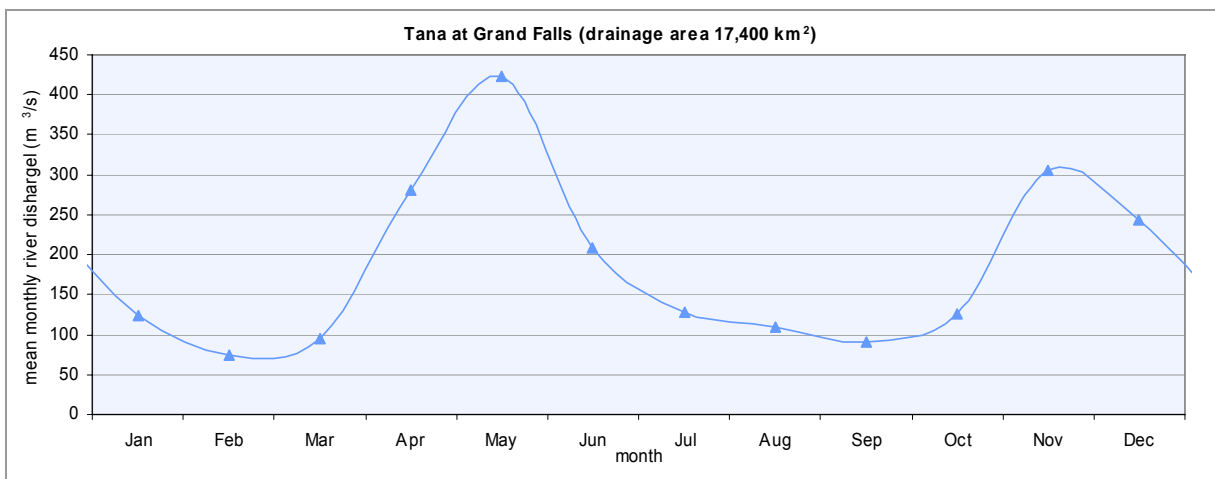
Figure 2.16 Mean monthly discharge of Tana River (1948-1971) (data: Louis Berger International Inc., 1983)

Figures 2.16 and 2.17 show the mean monthly discharges for the Tana River and a smaller seasonal river, the Kalundu river, located near Kitui town. The seasonal character of the flow is evident. In addition the inter-annual variation is significant (Louis Berger International Inc., 1983). It should be noted that the Kalundu river is located on the high-rain plateau near Kitui, smaller seasonal rivers in these areas and rivers in the dryer lower areas will have an even more accentuated variability.

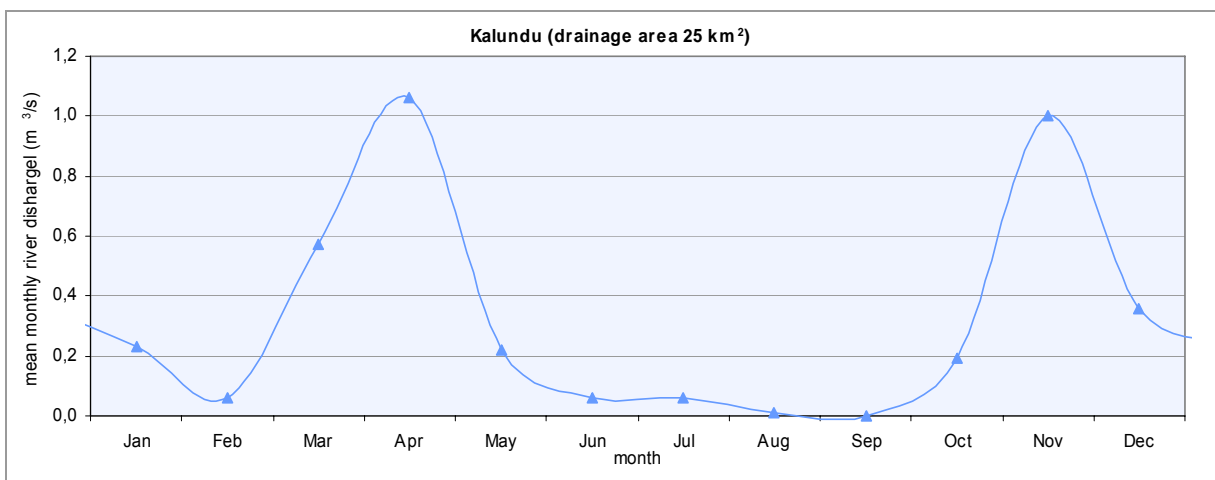
Figure 2.17 Mean monthly discharge of Kalundu river (1961-1976) (data: Louis Berger International Inc., 1983)

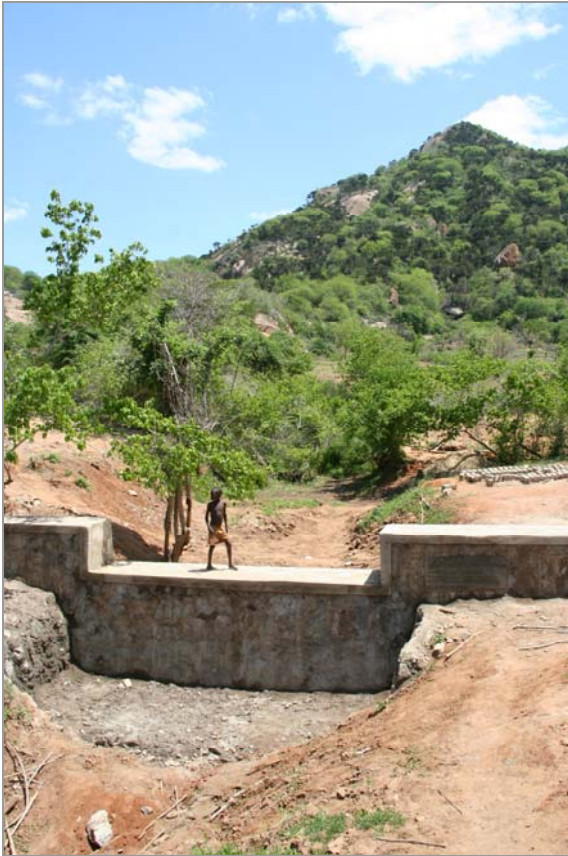
Figure 2.25 A recently finished dam build by SASOL near Kanziku, Kitui District

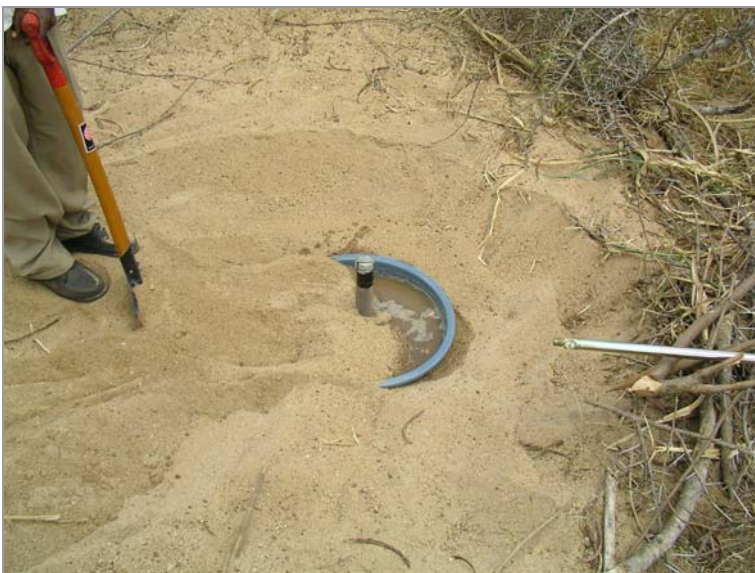
Figure 3.3 Sub-surface evaporation pan during installation

To get an indication of the amount of evaporation from the sand of the riverbed a sub-surface evaporation pan was installed in the Kiindu river. A circular plastic container (diameter approximately 0.5 m, height 0.5 m) was dug into the sand of the riverbed. A small piezometer was placed in the container after which the container was filled with the sand from the riverbed and saturated with water. The container was subsequently covered with sand and left alone for a few days to settle. After a few days the water depth in the sub-surface evaporation pan was monitored during a dry period of 16 days until the first rains arrived.

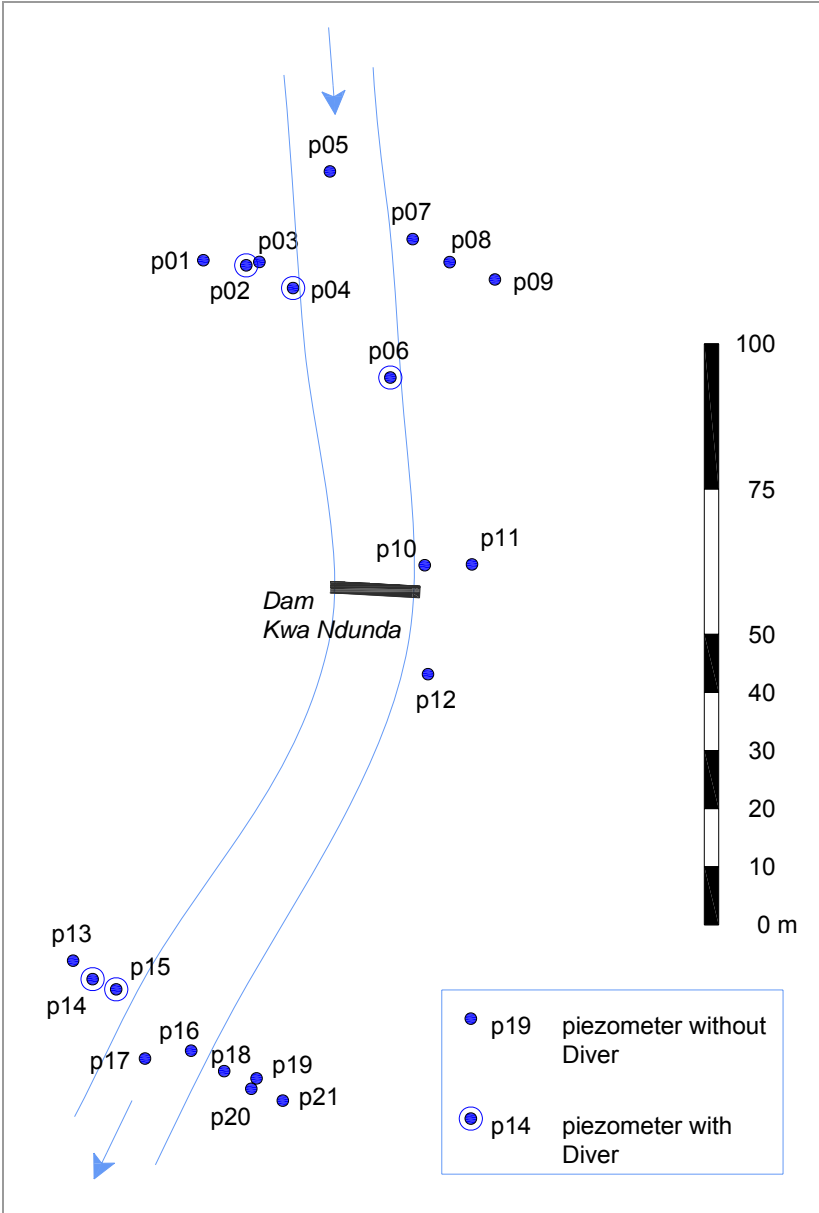
Figure 3.5 Overview of piezometers

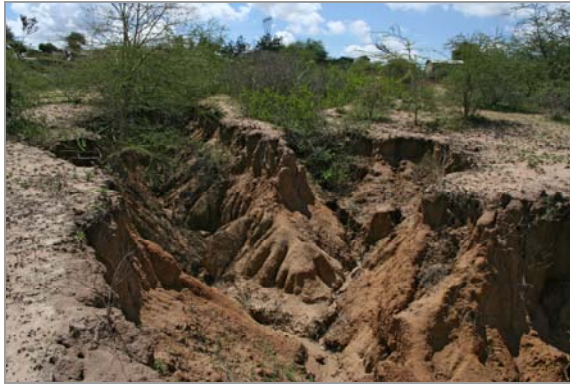
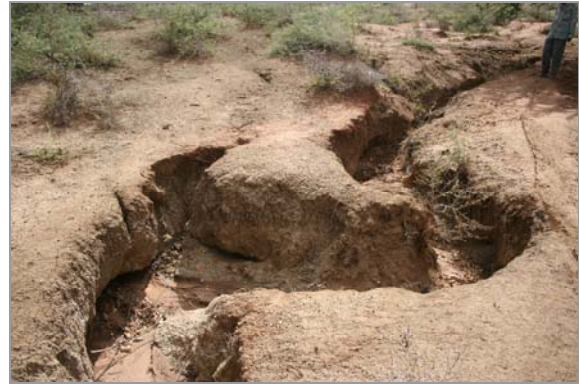
Figure 4.4 Soil erosion in the Kiindu catchment

Intense soil erosion is observed on riverbanks and on the slopes of catchments. Deep gullies (up to 3 m deep) have formed and are still increasing in depth, width and extend (Figure 4.4).

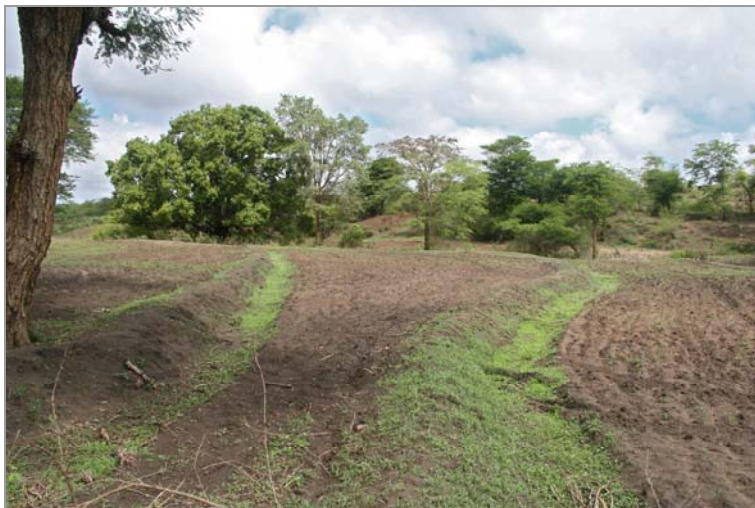
Figure 4.5 Terraces in the Kiindu catchment

At a number of locations terraces are constructed on the agricultural plots to protect the land against soil erosion and to improve infiltration in the soil (Figure 4.5). At some locations it is observed that terraces are constructed not parallel to the altitude lines. So education on soil conservation measures is necessary.

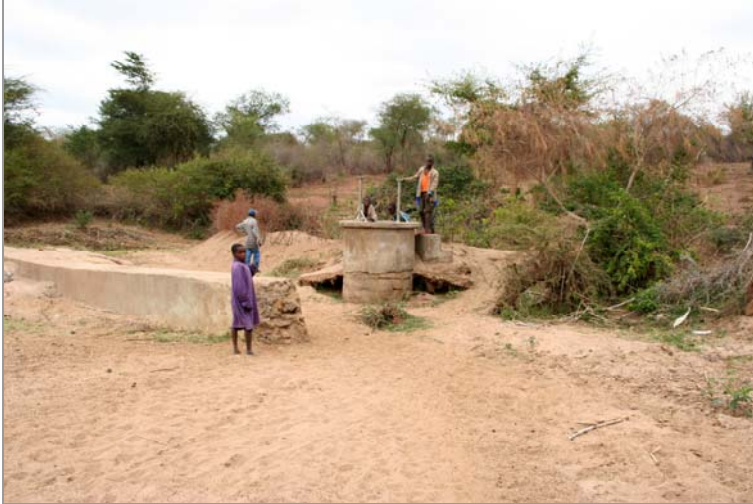
Figure 4.6 Change of river path next to a dam

Since the dams in the Kiindu river are the first dams SASOL has built, the design of the dams has improved since then. The dams in the Kiindu river are for example not equipped with a spillway, which has caused a number of dams to malfunction since the river changed its path to the side of the dam (Figure 4.6), or the dam broke through.

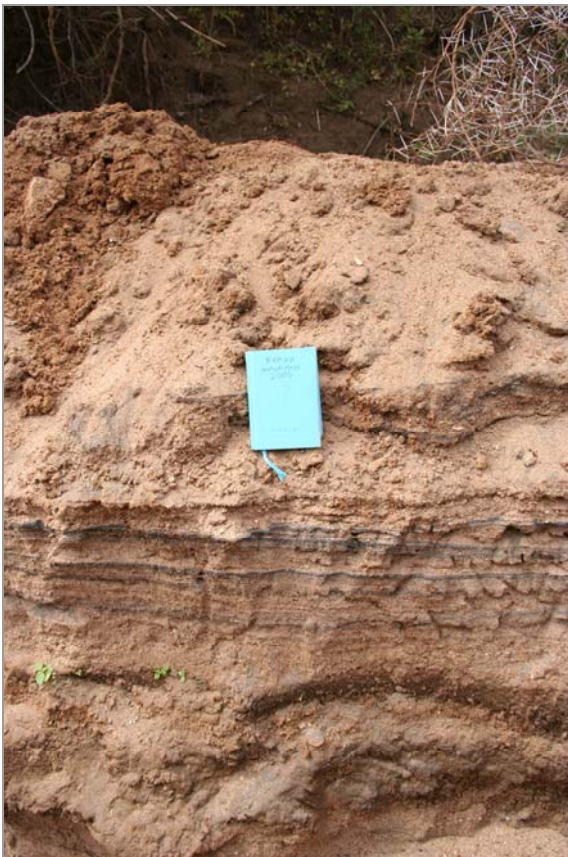
Figure 4.7 A scoophole in the riverbed of Ithimani river with one the highest amount of silt layers observed

From observations in scoopholes in a number of catchments around Kitui town it was found that in most of the cases the sediment in the riverbed consists solely of coarse sand with bands of fine gravel. At some locations minor silt layers are observed in the sediment of the riverbed. In the Kiindu catchment no silt layers were observed in the sediment.

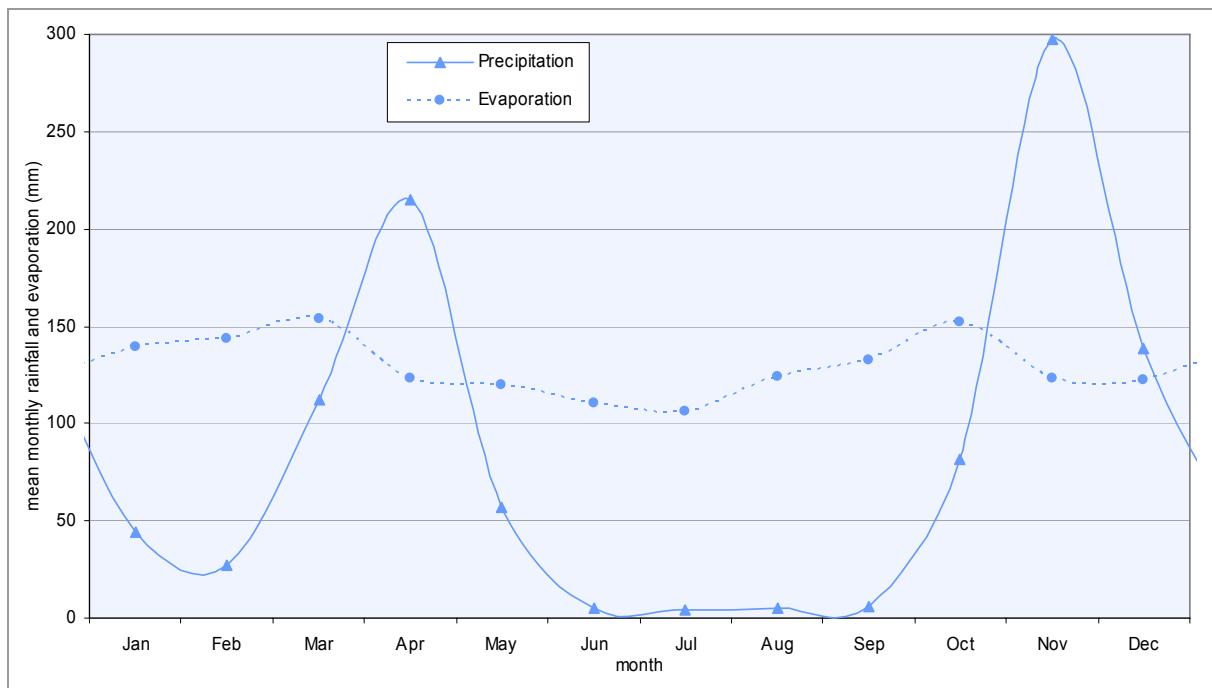
Figure 4.9 Monthly variations of rainfall and evaporation in Kitui

Rainfall is mostly concentrated into two rainy seasons: the so called “long rains” which last from March to May and the “short rains” which last from October to February (see Figure 4.9). Mean total rainfall during the long rains is 385 mm, with a standard deviation of 116 mm. Mean rainfall during the short rains is 590 mm, with a standard deviation of 138 mm. The names “long rains” and “short rains” are not related to the length or amount of the rains, but refer to the length of individual rainfall events.

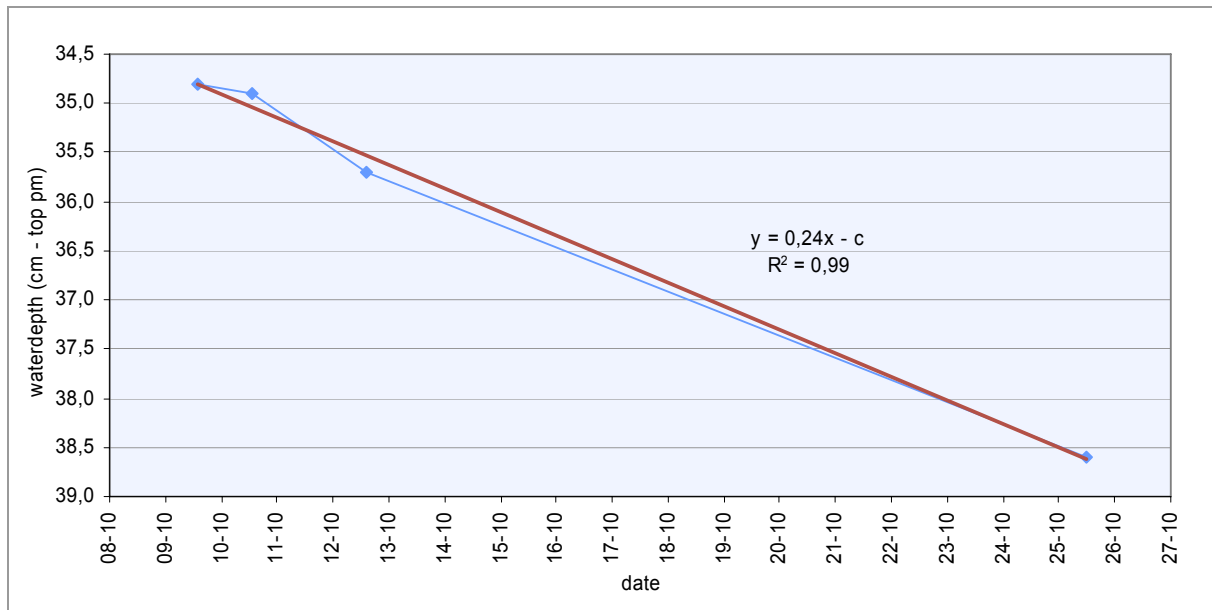
Figure 4.12 Observed evaporation in the sub-surface evaporation pan

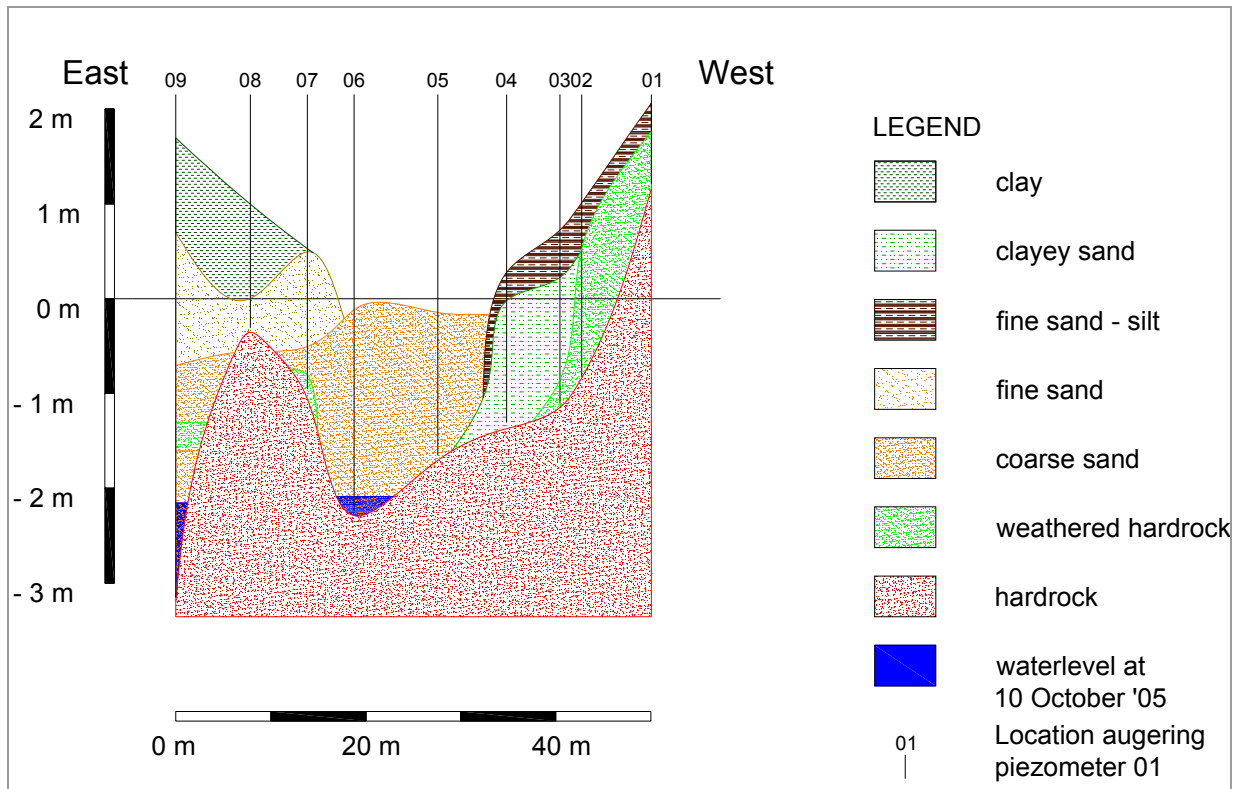
Figure 4.13 Upstream cross-section. The direction of sight is downstream

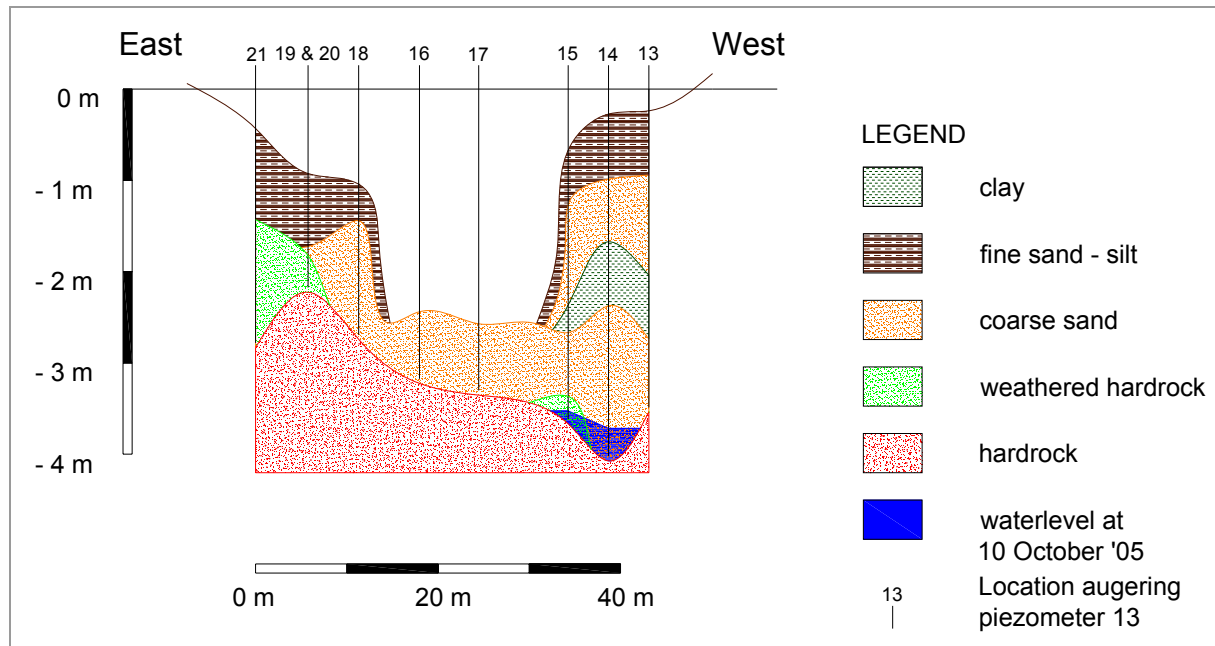
Figure 4.14 Downstream cross-section. The direction of sight is downstream

Using the borehole data the following cross-section is drawn (Figure 4.14).

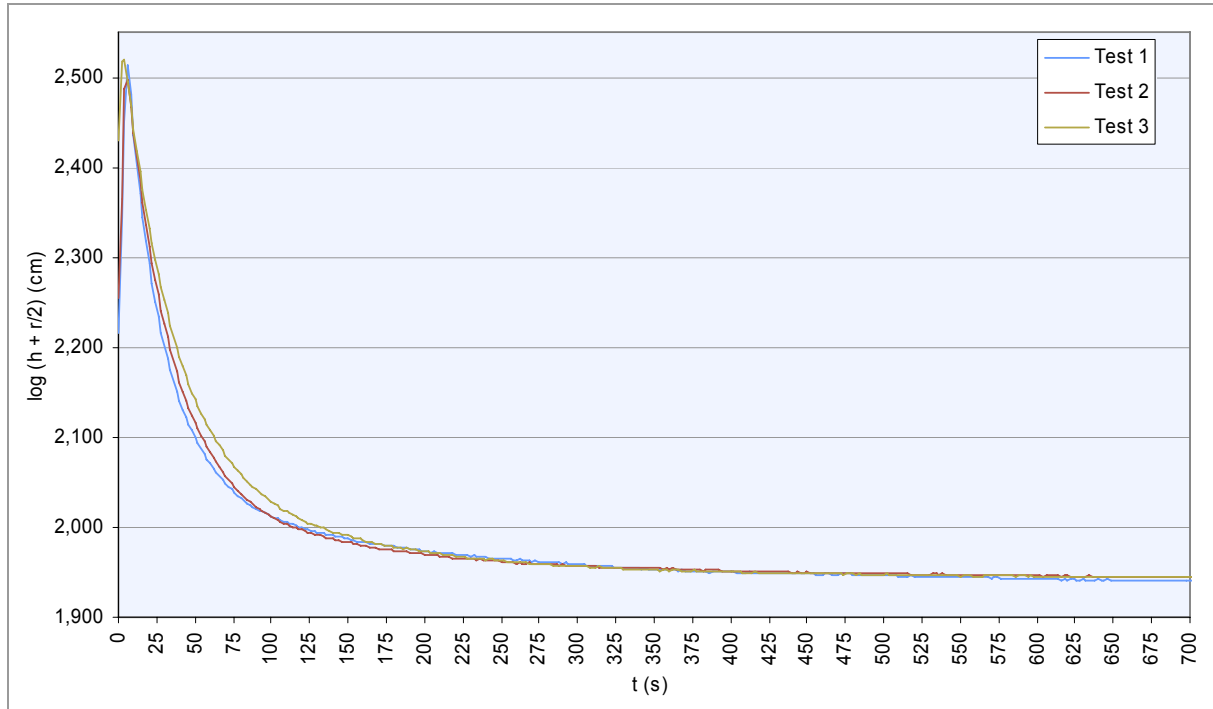
Figure 4.15 Results from inversed auger hole tests in piezometer 15

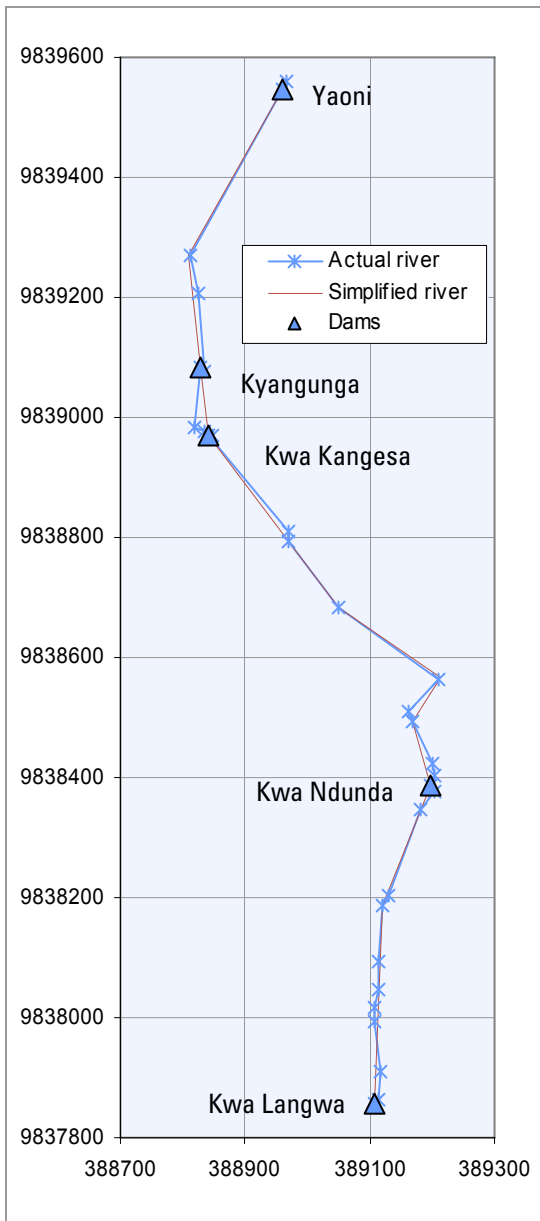
Figure 4.16 Actual and simplified path of river (UTM coordinates)

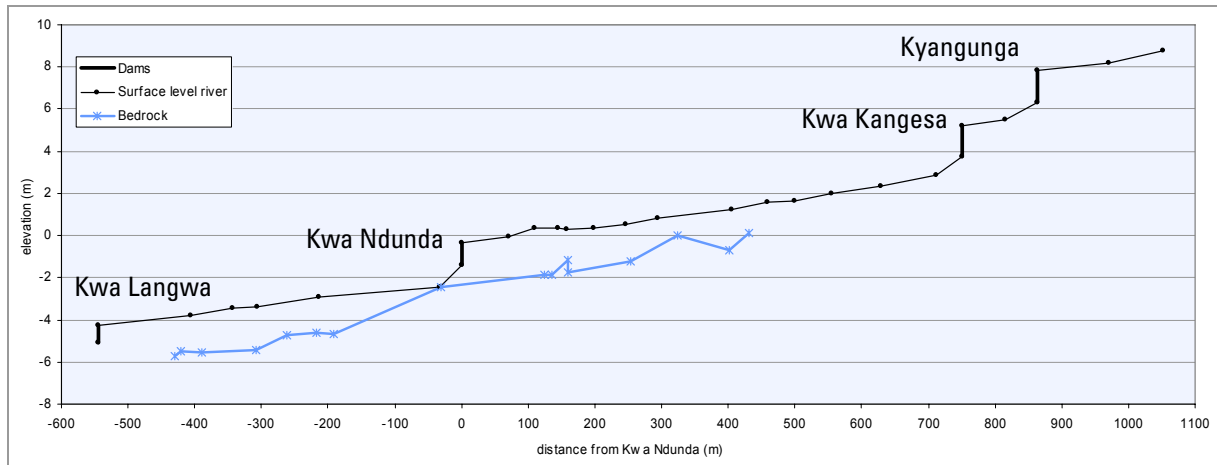
Figure 4.17 Longitudinal profile of the surface level of the river and the hardrock

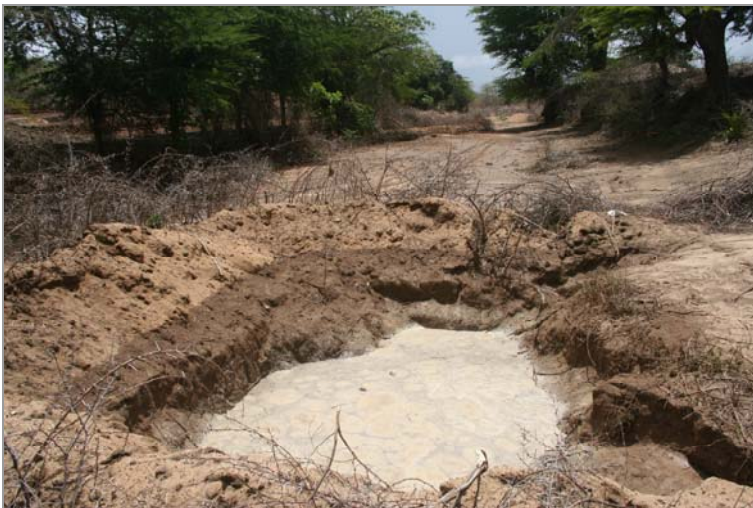
Figure 4.18 Scoophole filled with surface water during the night

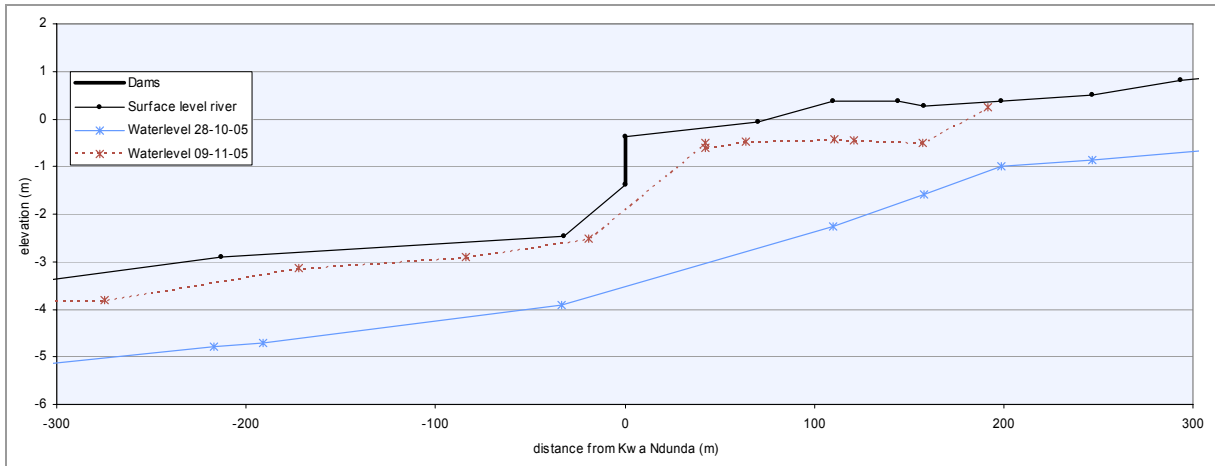
Figure 4.21 Detail of the step change in water levels around dam Kwa Ndunda

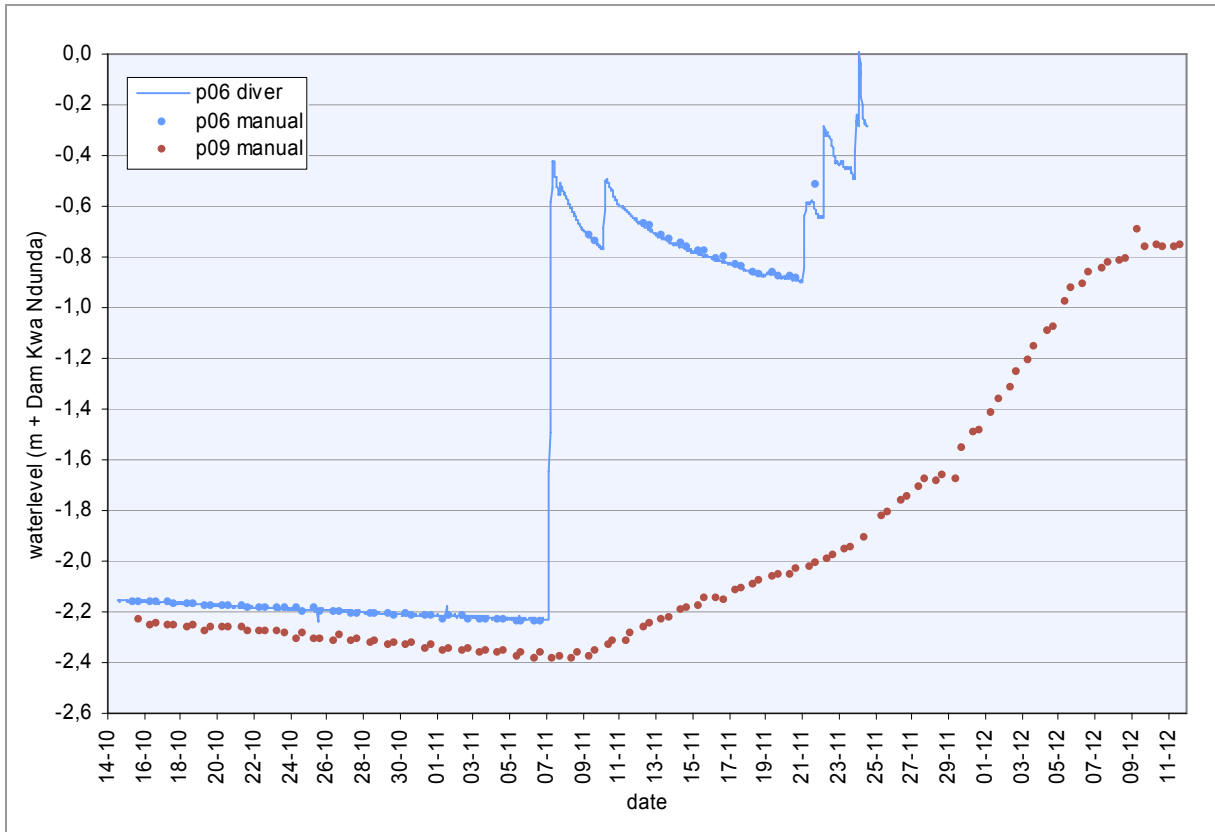
Figure 4.23 Water level in the riverbed and the riverbank (p06 and p09)

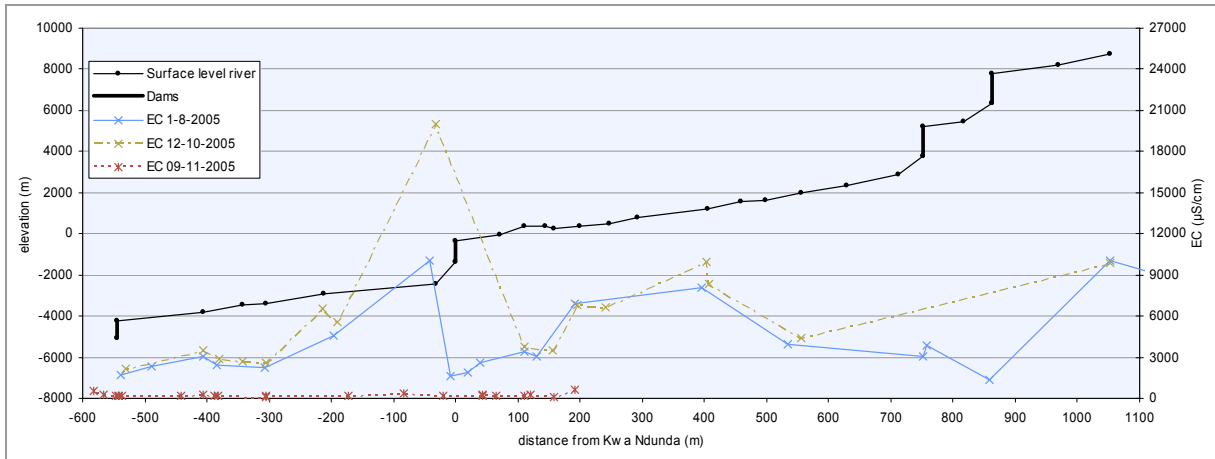
Figure 4.27 Longitudinal profile with EC

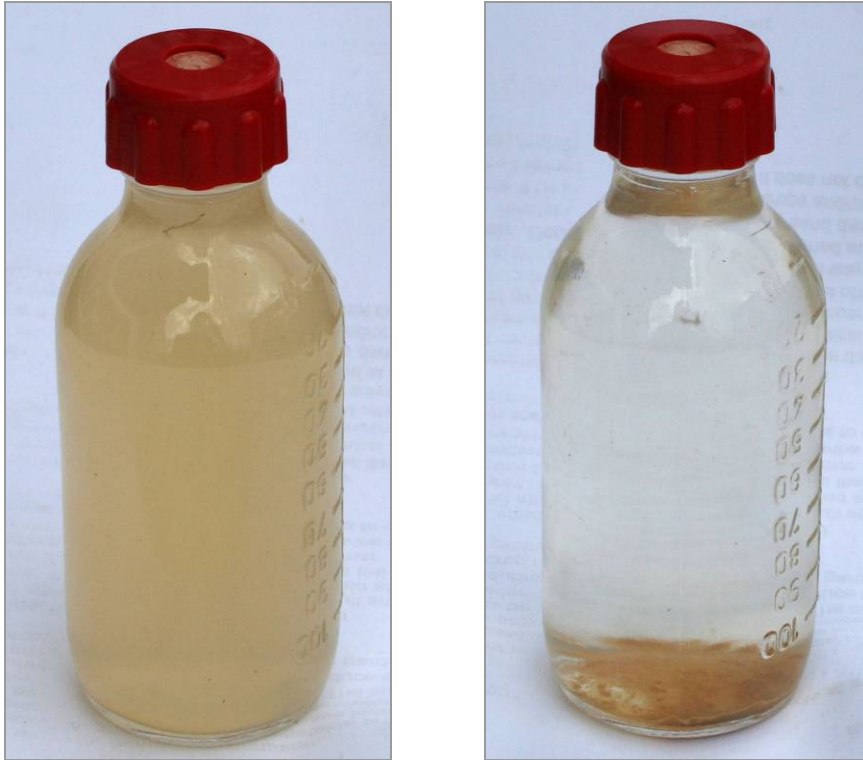
Figure 4.28 Sample with water from a well before (left) and after (right) settling

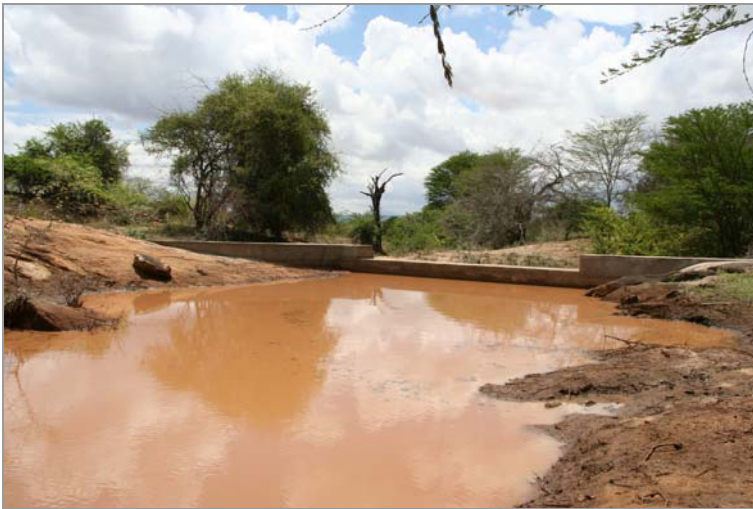
Figure 5.1 Surface water pool behind a recently constructed dam

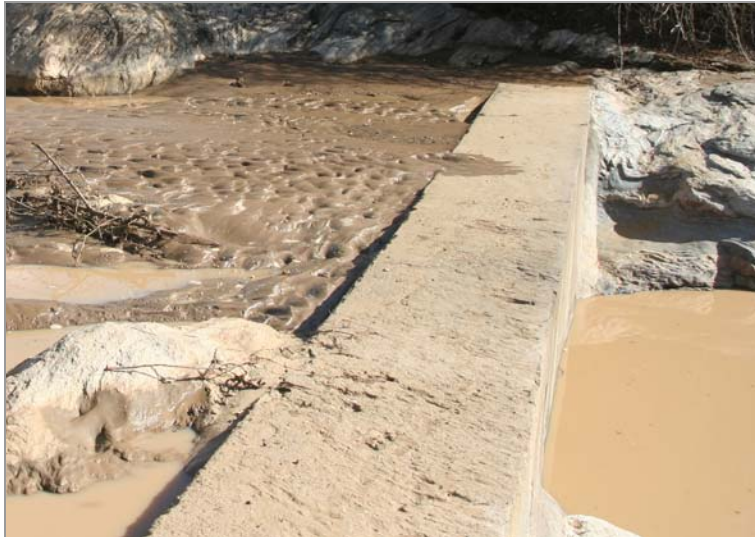
Figure 5.2 Sediment flowing over a dam

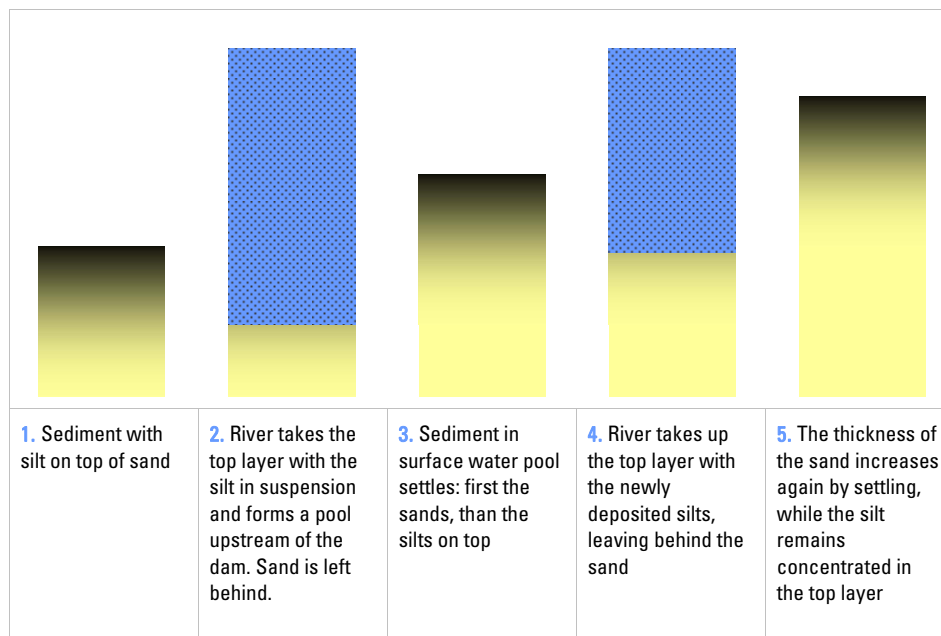
Figure 5.3 The process of sedimentation upstream of a sand storage dam

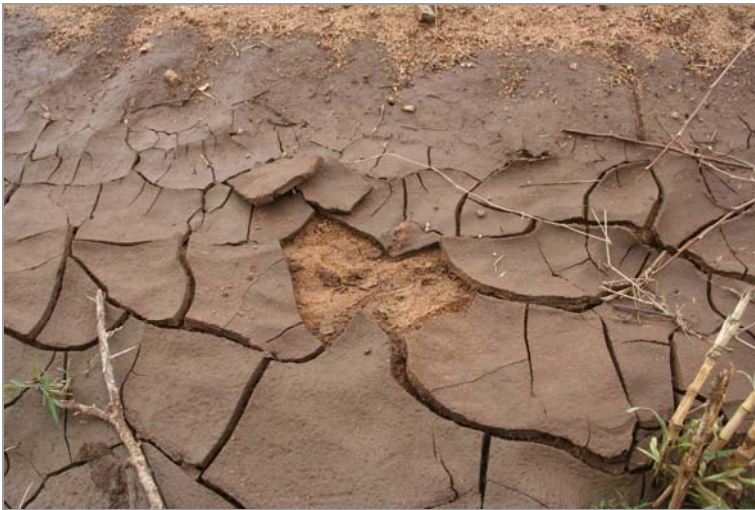
Figure 5.4 Silt layer on top of the coarse sand of the riverbed

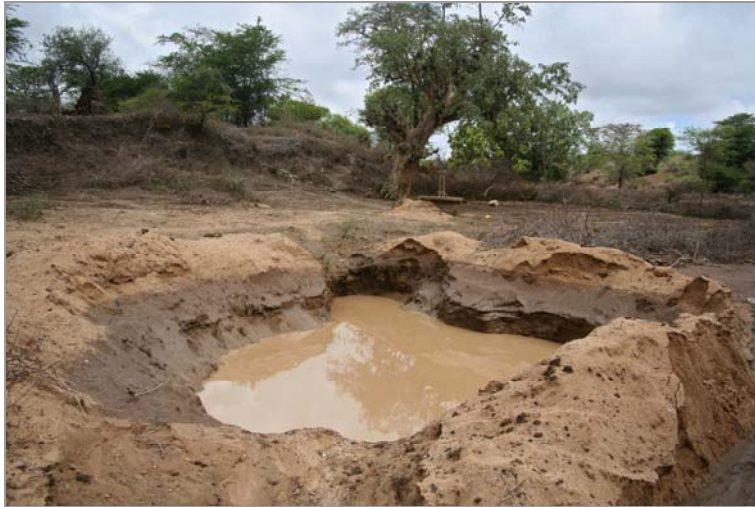
Figure 5.6 Silt layer on the sides of a scoophole

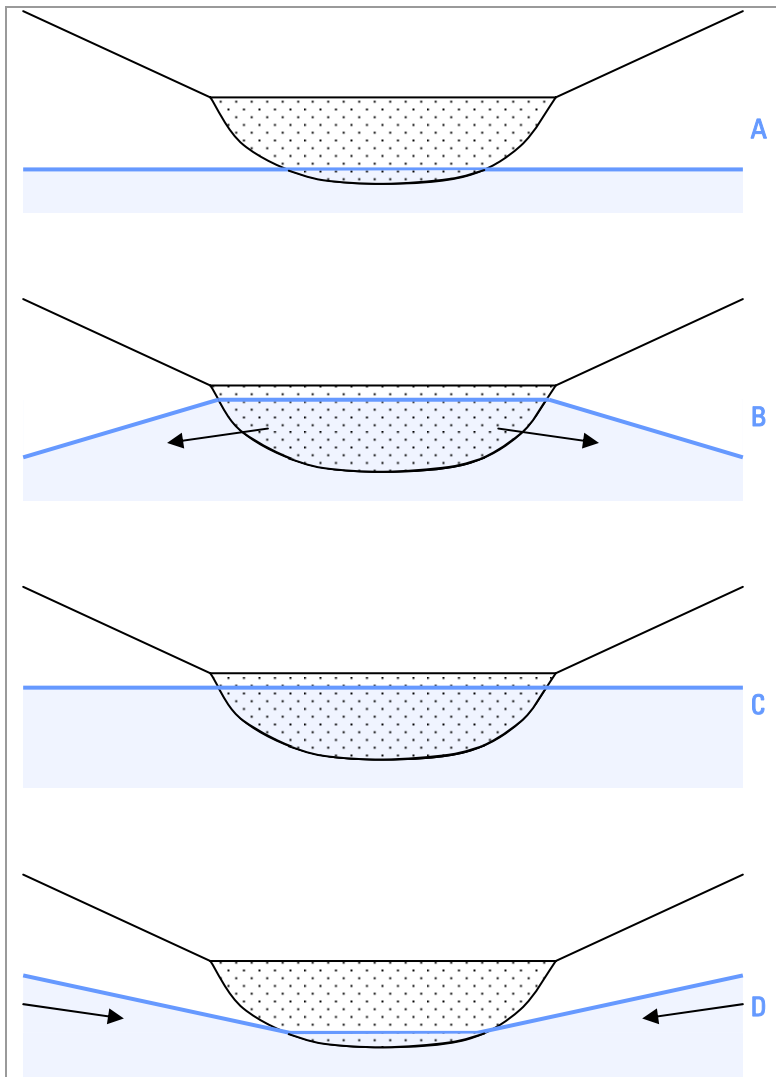
Figure 5.9 Schematic cross-sections over the riverbed: low water level (A), recharge from the riverbed to the banks (B), high water level (C) and recharge from the banks to the riverbed (D).

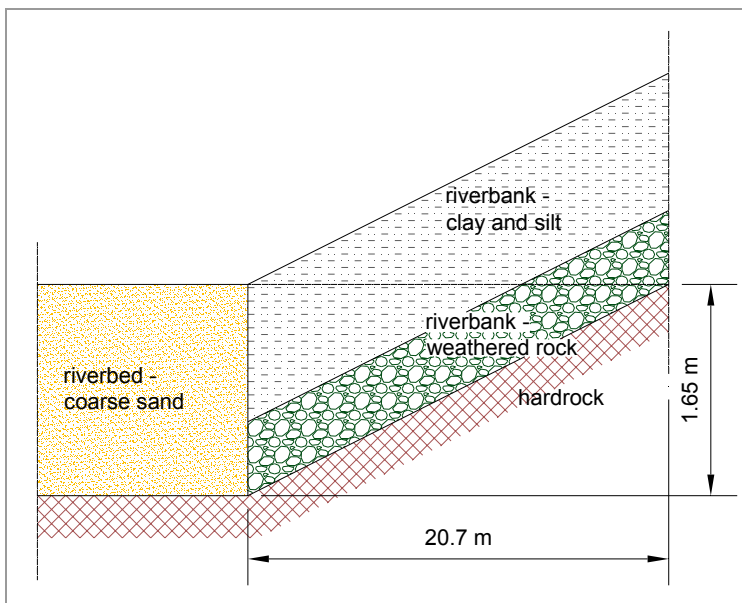
Figure 5.13 Schematised cross-section of the riverbank

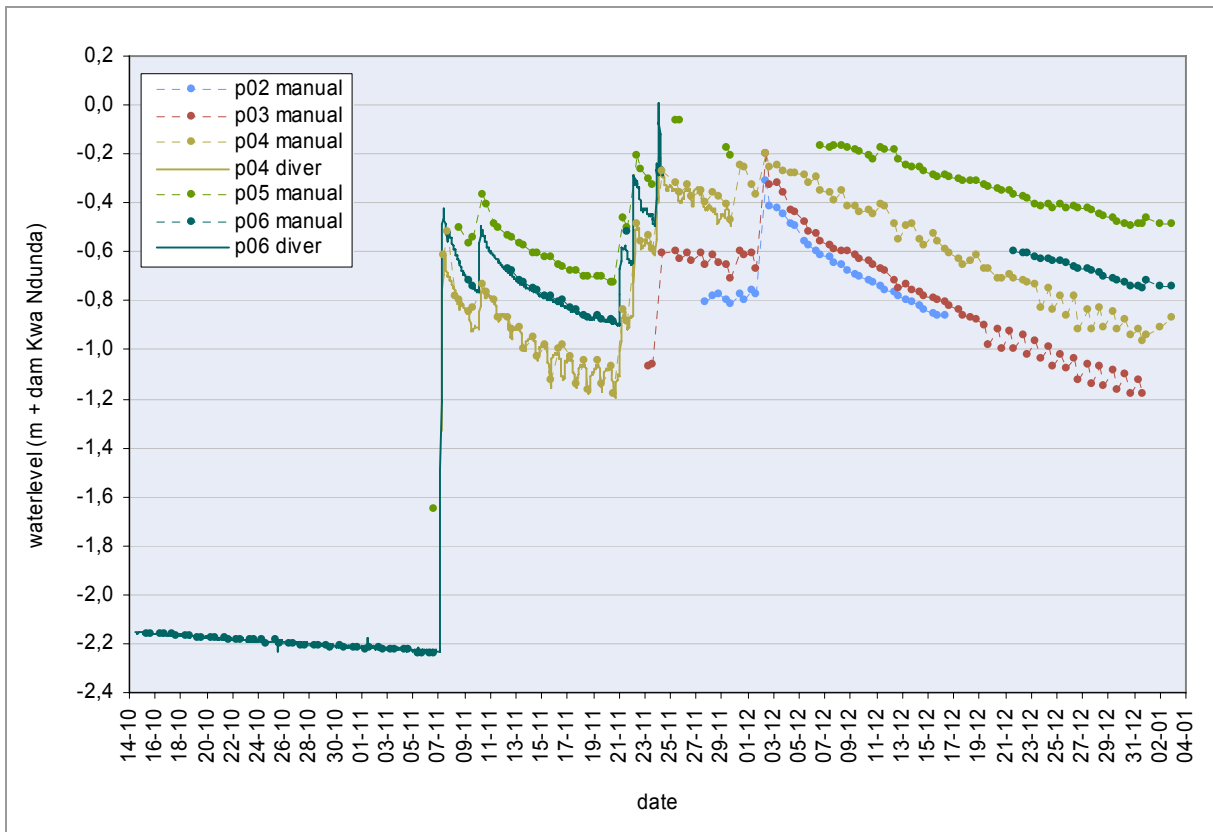
Cross-section North of dam Kwa Ndunda, Western part

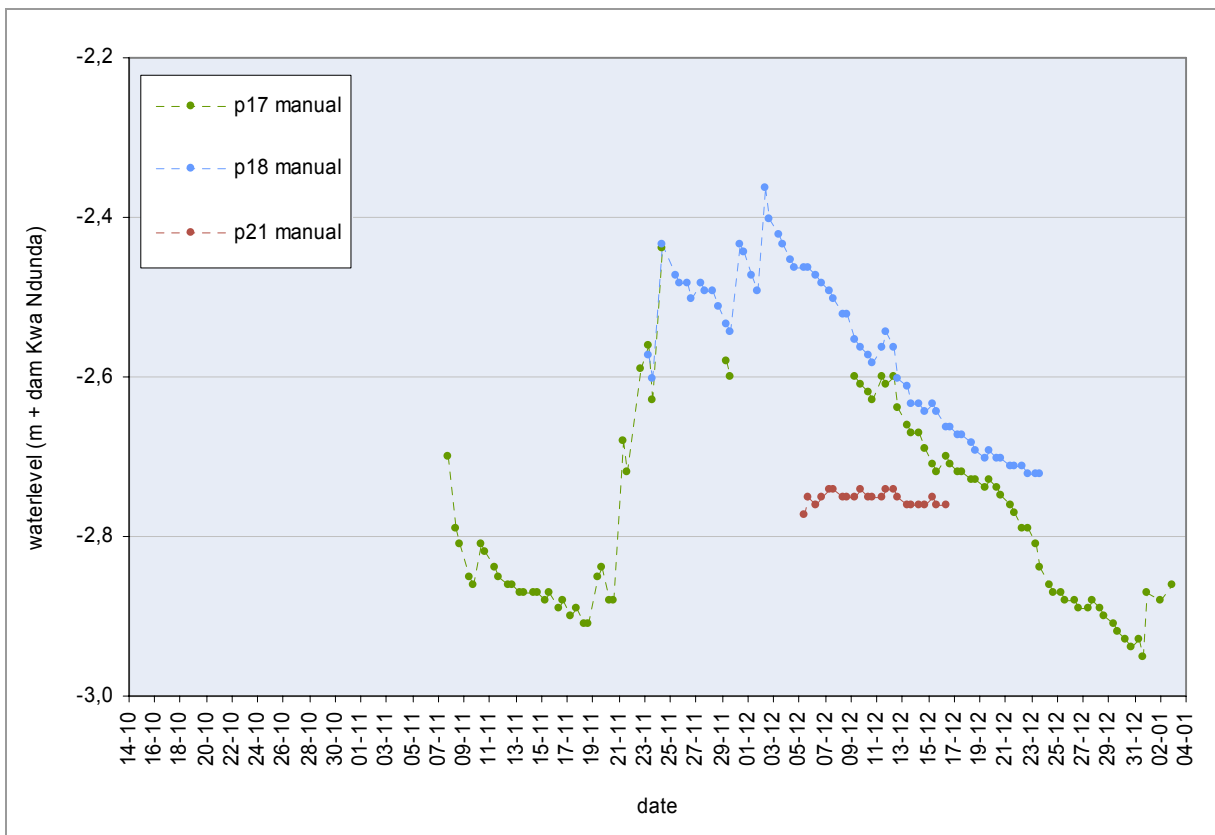
Cross-section South of dam Kwa Ndunda, Eastern part
